## EVALUATION AND ASSESSMENT CUTLER ELEMENTARY SCHOOL 31 S. WINCHESTER STREET SWANZEY, NEW HAMPSHIRE

FOR  
MONADNOCK SCHOOL DISTRICT  
SAU #93, SWANZEY, NEW HAMPSHIRE  
JUNE 30, 2017

The H.L. Turner Group Inc.

### **Facility Assessment**

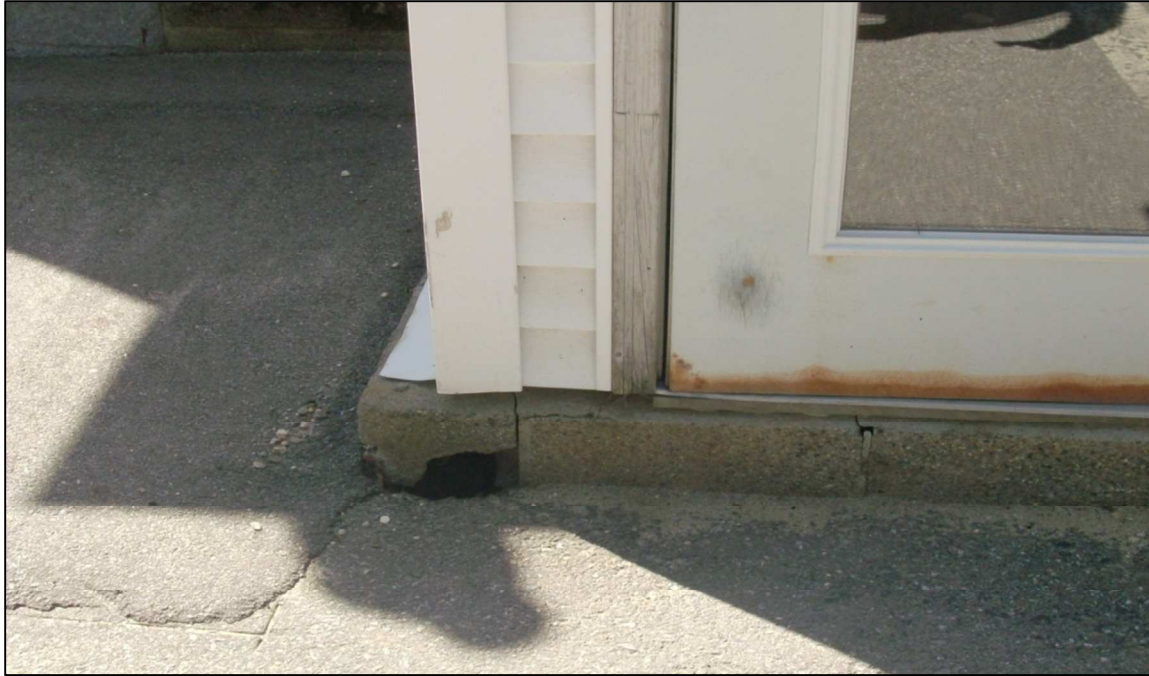
At the northeast corner there is a walk-up stair to grade from the basement literary room. The door at the top of the stairs is badly rusted at the base, presumably from splash back of rain on the asphalt. There is a visible gap in the corner of the foundation of the stairway and it appears water is able to enter into the foundation wall unimpeded at this spot. In addition, the door opens directly into a vehicular circulation path. In fact, there is a stop sign mounted to the side of the stair enclosure indicating how close it is to the vehicular pathway. At the north wall of this structure where it joins to the 1945 addition, runoff from the pitched roof of the original building sheds onto the face of the masonry wall. There is heavy staining and mortar joint deterioration of the brick at this point. A gutter and downspout, or additional crickets should be considered for this location. We observed some minor mildew growth evident on the vinyl siding at the north wall.

Exit from the basement level of the original school. Note rusted door and hole in foundation.

- Rebuild the stairs on the northwest corner of the building such that it is in compliance with current codes. (\$12,000)
- Repair the gap in the foundation at the stairway exit from the literary room. Replace the door. (\$5,000)

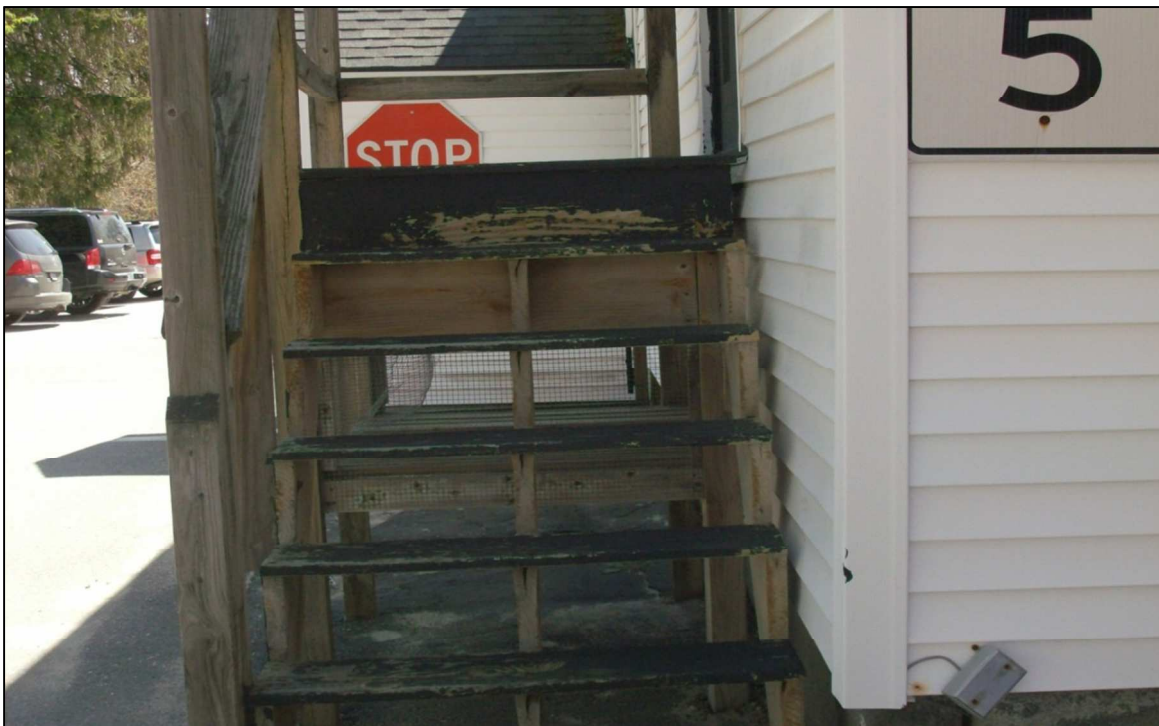
need of scraping and painting. At the northwest corner of the building there is a set of exterior wood stairs from the classroom to grade. The stair set is sheltered by a wood framed shed roof canopy. The entire stair set is in disrepair. The risers are too steep and the treads are not wide enough to be in compliance with current building codes. Furthermore, there are no handrails.

Non-compliant stair set providing exit from a classroom on the main floor of the original building.

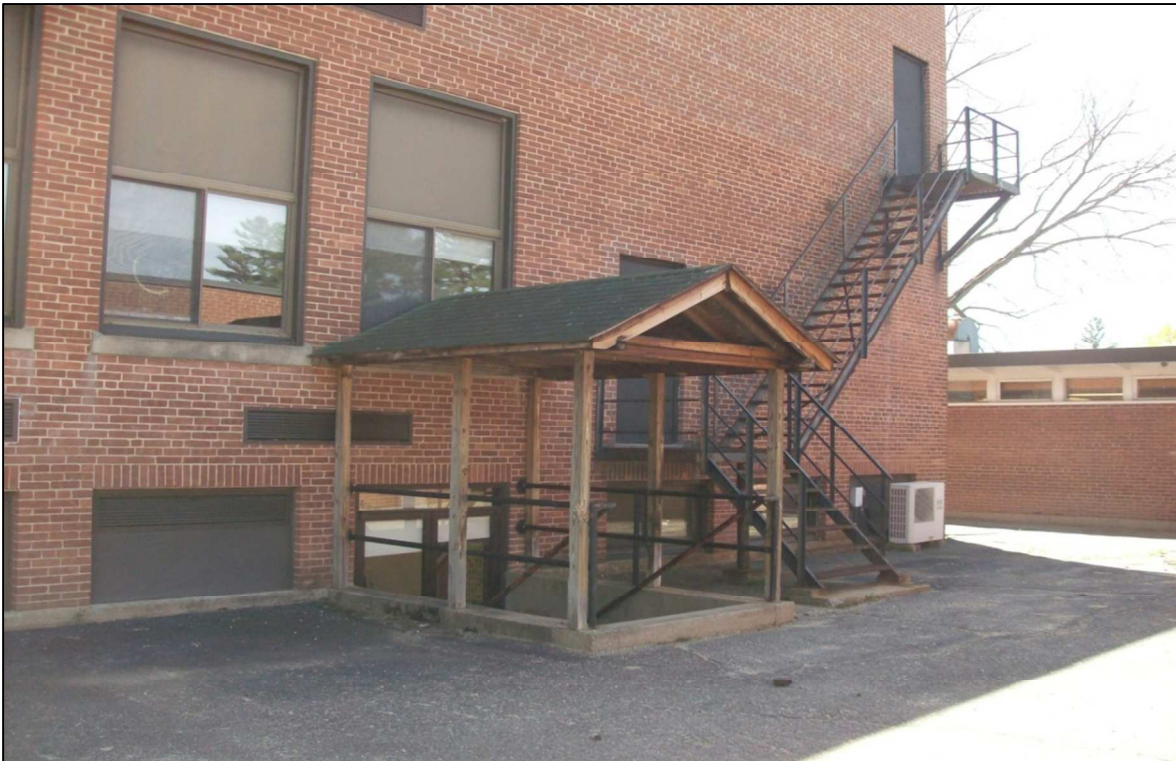
There is a canopy over the walk-up stairs from the basement library. This is built of pressure treated lumber that hasn't been painted or stained. The post bases show signs of discoloration and much of the pressure treatment may have leached out. The posts should be continually monitored for deterioration and rot.

There are exits from the rear of the 1945/1950 additions via a door onto a steel framed platform with a set of steel framed stairs. These are used only in the event of an emergency. At some point in the near future, the stairs will require close inspection for corrosion and weld cracks, and will require a new coating of paint.

Wood framed canopy over basement exit. Also steel fire exit stairs from first and second floors.

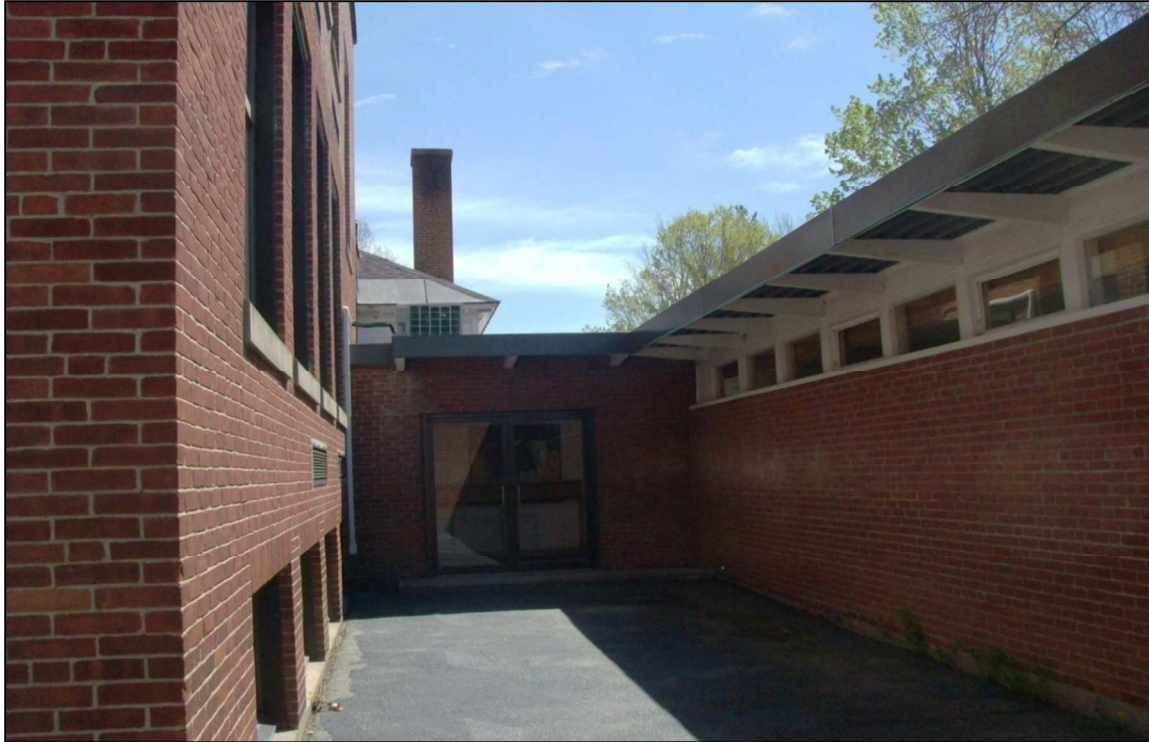
On the east facing wall of the 1970's addition near the main entry, we observed some staining, most likely from moisture, at the base of the wall from possible splash back from the asphalt. Also the north side of the 1970's addition has a roof overhang supported by a series of tapered wood beams that support the metal roof deck. Some of the outriggers have peeling paint and should be checked up close for decay or deterioration.

Paved courtyard between the 1945/1950 and 1970 additions.  
Note overhanging wood roof support beams.

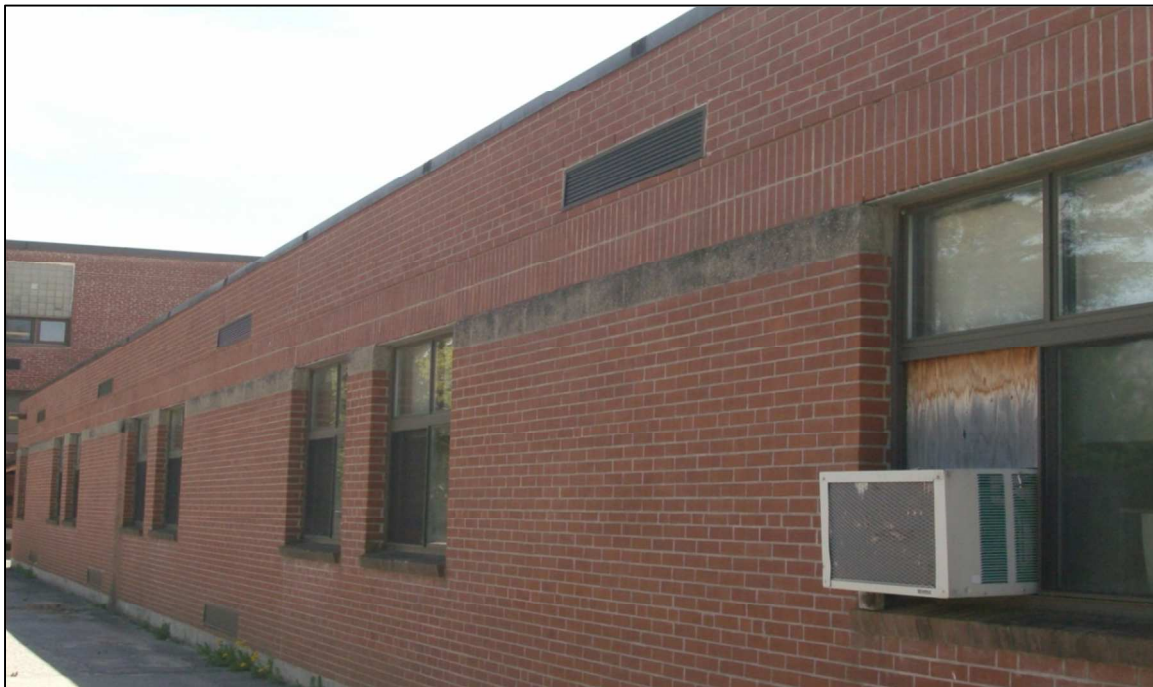
At the 1996 addition, the north-facing walls of the gym and kitchen show mildew and moisture staining. No efflorescence is evident, but there may be trapped moisture in the cavity that is not drying out. On the north wall of the 1996 classroom addition there is a split face CMU accent band in the brick veneer. At various locations it appears water drips over the gravel stop at the roof and hits the projected split face block. We observed moss growing on the split face block and staining above and below on the brick veneer. There was some slight efflorescence on the masonry veneer in these spots as well. Efflorescence is a crystalline deposit on the surface of the masonry. These are deposits of salts that originate in the mortar or block itself, and when combined with moisture, are driven by pressure differences through the porous masonry to the surface. As the water evaporates it leaves the salt deposits behind.

North façade of 1990's wing. Note staining on precast accent piece and individual AC unit.

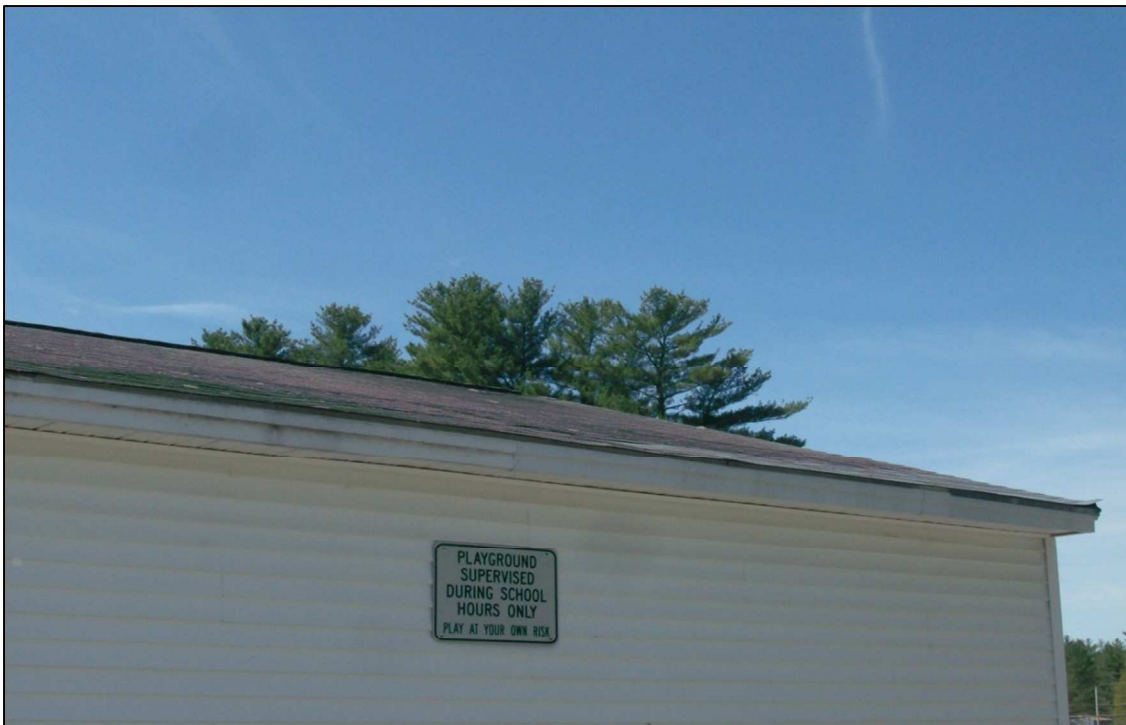
There are two wood framed, modular style classrooms that were moved from a remote location on the school grounds to a position off the west side of the 1996 addition. The units are situated on a concrete perimeter frost wall with interior footings and piers. The area below the portable units is a crawlspace and there are some small vents on the sides of the units. But unless there is sufficient air movement, the floor framing of the portable is likely suffering from mold growth and possible wood decay. The exterior of the modular units are vinyl covered with a shingled roof. The roof is in poor condition and is in need of replacement. There is heavy mildew build-up on the north face of one of the units. The entrance to the modular units includes a wood ramp for handicap accessibility. Judging by the age and overall condition of the modular units, it is our opinion that they are past their useful life and should be replaced sooner than later with permanent classrooms.

Shingle roof of portable units nearing end of life.

- Replace the modular classroom with an addition onto the school. (\$500,000 to \$600,000)
- Investigate the cupola support and provide a more substantial support system (\$6,000)

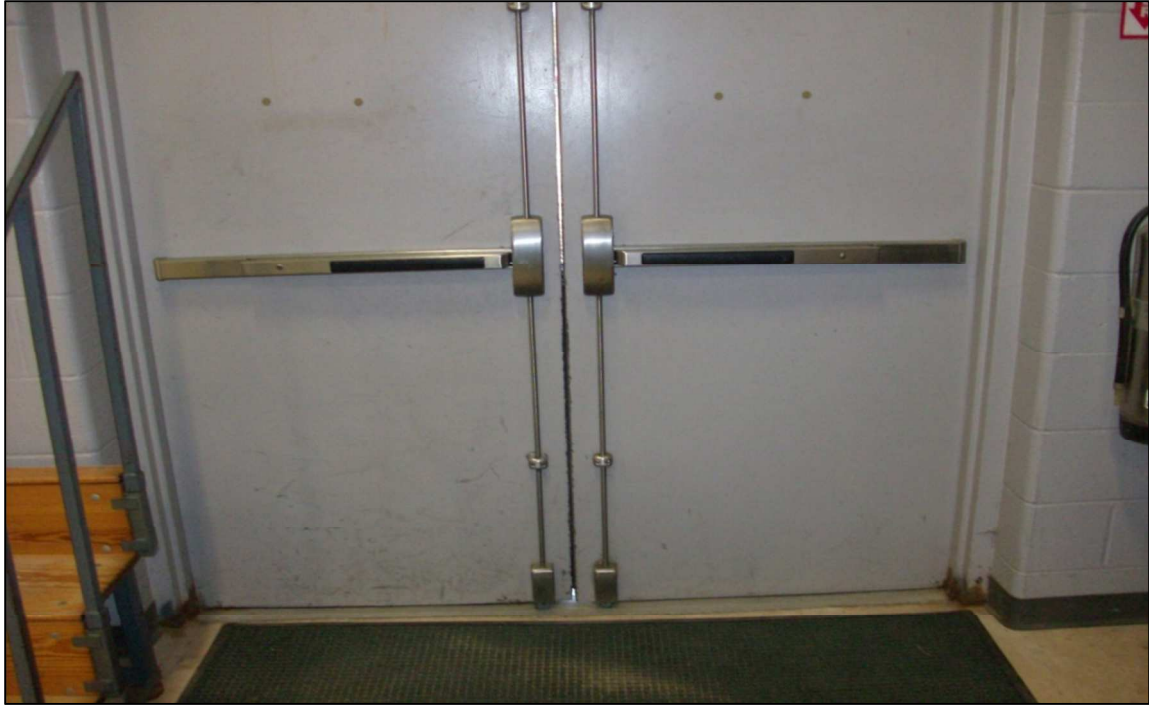
The gymnasium and kitchen are part of the 1996 addition. Both are in good condition. The gym has a seamless vinyl/rubber sheet product which is in good condition. However, the lines on the floor are badly worn and require repainting. Another item requiring attention includes the double doors; they are lacking astragal seal strips to cover the space between door halves. There is also some corrosion at the bottom of the door frames and the doors will have to be replaced in the next five to six years. The gym heating and ventilation is provided by two large ceiling mounted units. The units are over 20 years old and may need replacement in the next five to six years. Having the units suspended from the ceiling presents some difficulties in terms of ease of access for maintenance purposes.

Doors at gym. Note lack of astragal between doors and corrosion at door frame.

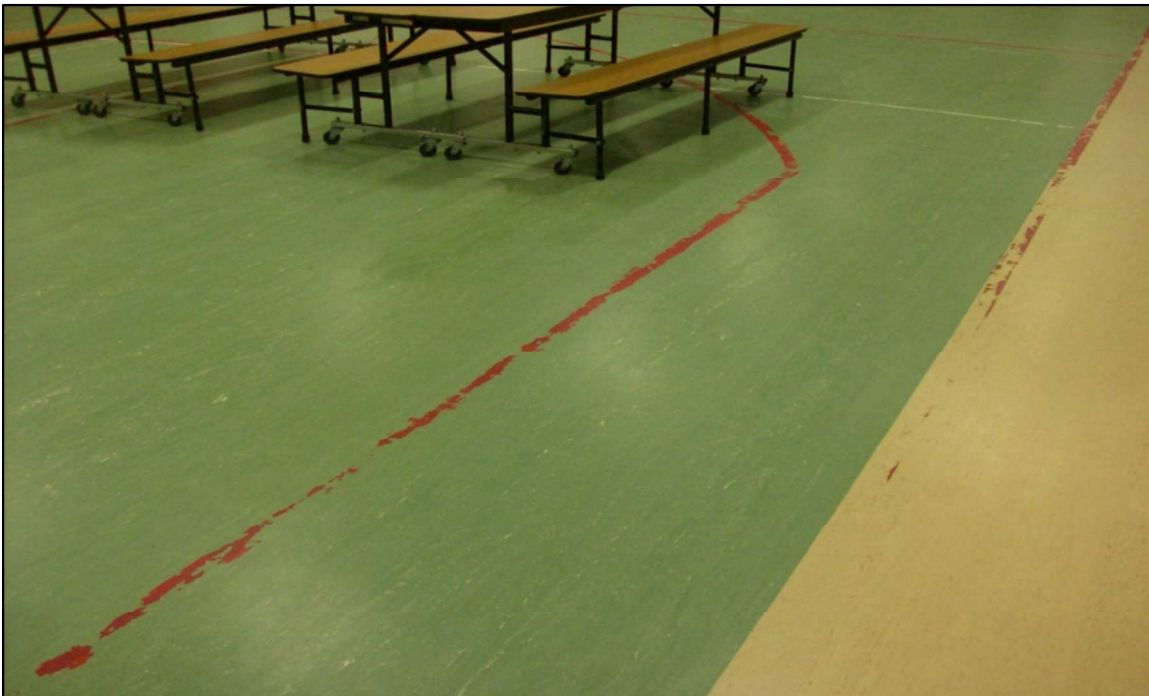
Lines on gym floor need repainting.

- Update the fire alarm panel (\$75,000)
- Re-paint the lines on the gymnasium floor (\$3,000)
- Clean soot/creosote from chimney (\$1,500)

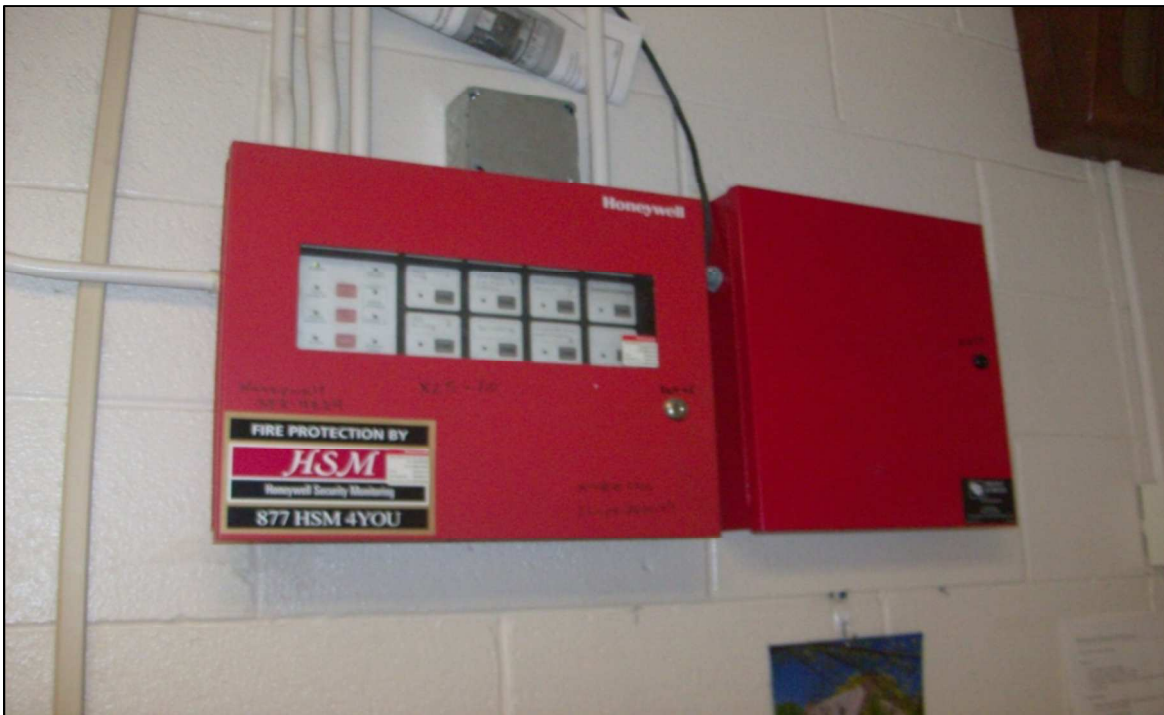
The building is fully covered by a sprinkler system. There are heat and smoke detectors throughout the building, as well as horns and strobes. However there is a lack of horns and strobes in some of the bathrooms. Also the fire alarm panel is outdated and should be upgraded.

Fire alarm panel needs upgrade to new modern addressable panel.

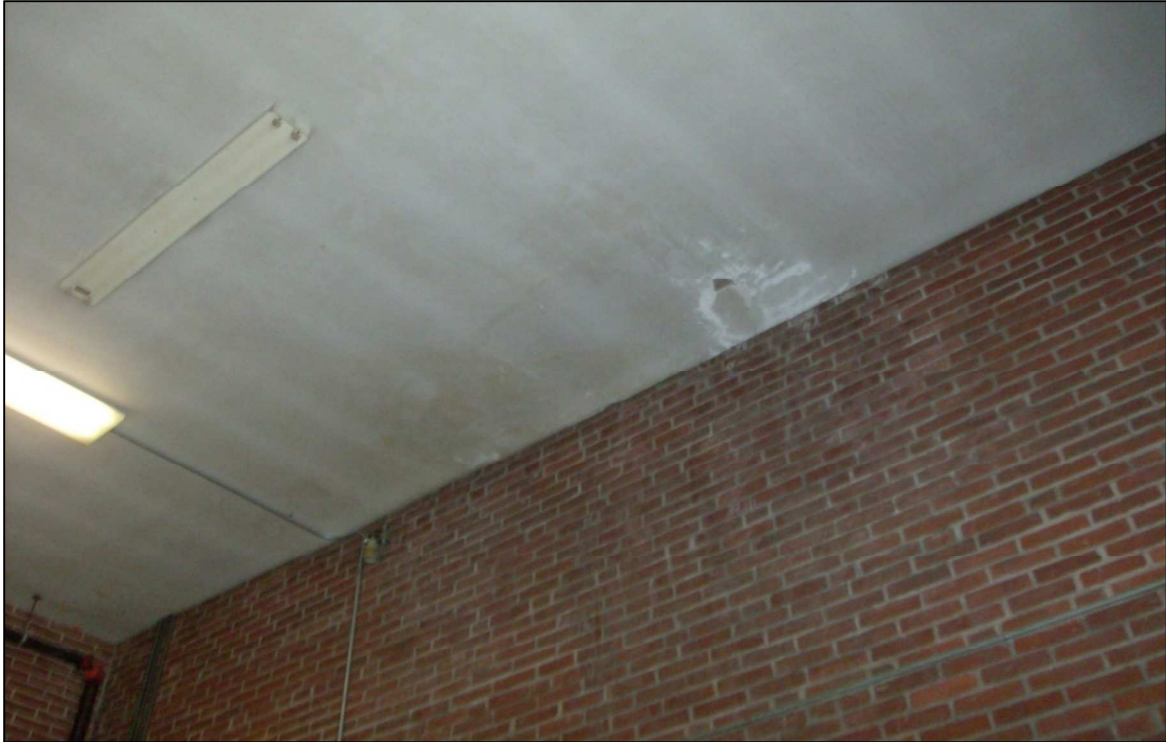
Staining on ceiling of stairwell between 1945/1950 and 1970's additions.

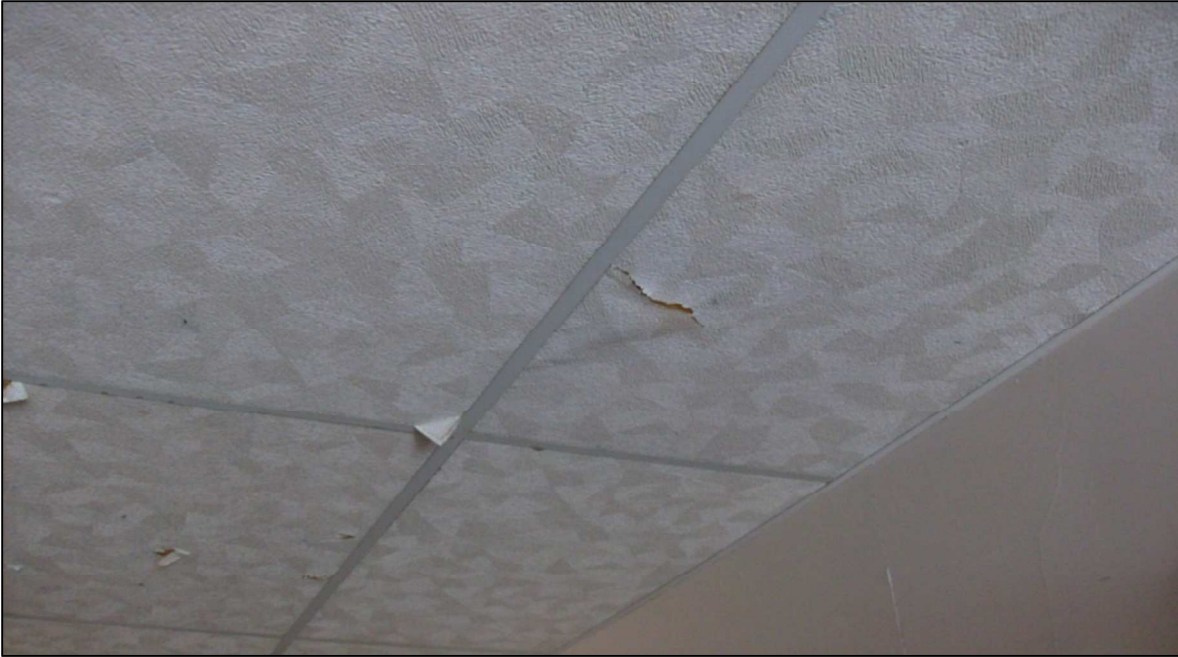
Most of the ceilings are suspended, or drop ceilings, with acoustical tiles. The ceilings appear to be in good shape throughout the early 1970's and 1997 addition. There is some staining in the main corridor tiles of the 1970's building, possibly from roof leaks in this area. In the original building some of the foam backed acoustical ceiling tiles have rips and tears in the vinyl facing at several locations. The ceiling in these areas should be replaced. In this same area, the classrooms and some hallway areas have plaster ceilings. In some areas we observed staining and hair line cracking.

Damage to vinyl coated acoustical ceiling tile in the original section of the school.

- Replace the roofs over the 1950's and 1970's additions. Approximately 9,400 square feet of roofing. (\$100,000 to \$115,000)
- Replace the foam backed acoustical ceiling tiles in the original section of the building (\$10,000)

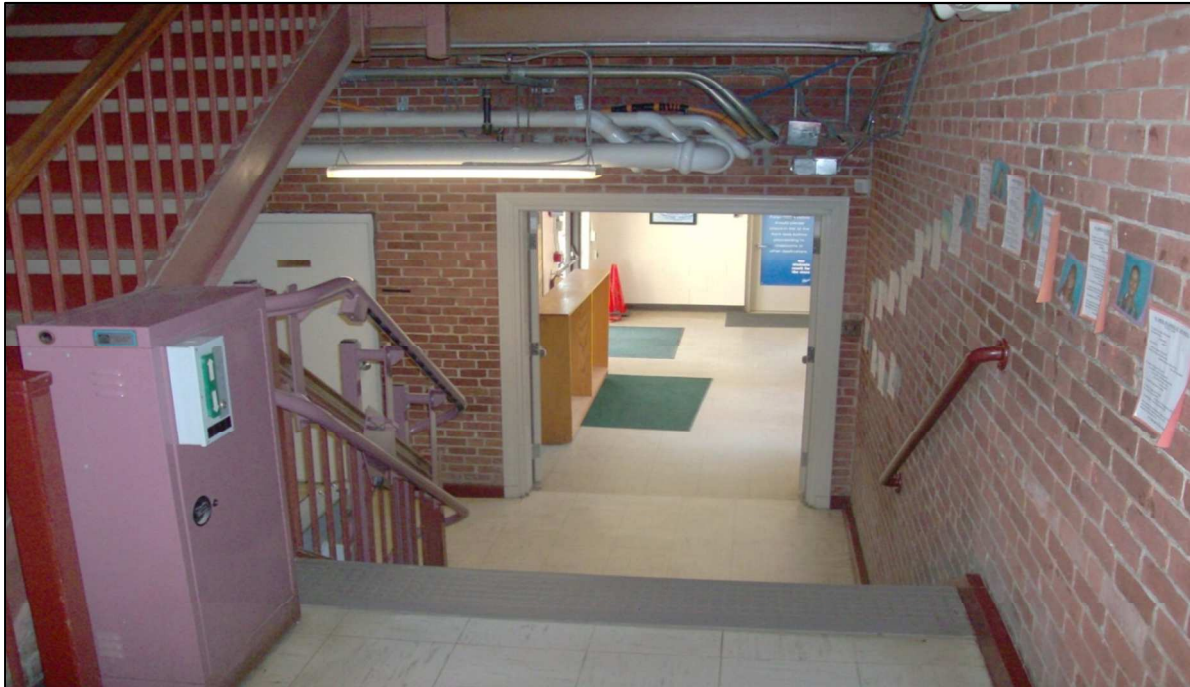
Accessibility – There is a stair mounted chair lift from the main entry at the 1970’s building to the first floor and basement of the 1945 addition. There is no accessibility to the second floor (1950 addition) classrooms, or any of the original wood structure classrooms. The original wood structure is down several risers from the floor of the 1945 wing. The 1970’s and 1996 additions are fully accessible with on-grade entrances and a ramp into the modular classrooms, both from the interior floor level change and parking lot outside. There are accessibility issues with the bathrooms as previously mentioned.

Stairway to library in basement of original section of school.  
Note chair lift from basement to first landing. It does not extend above that level.

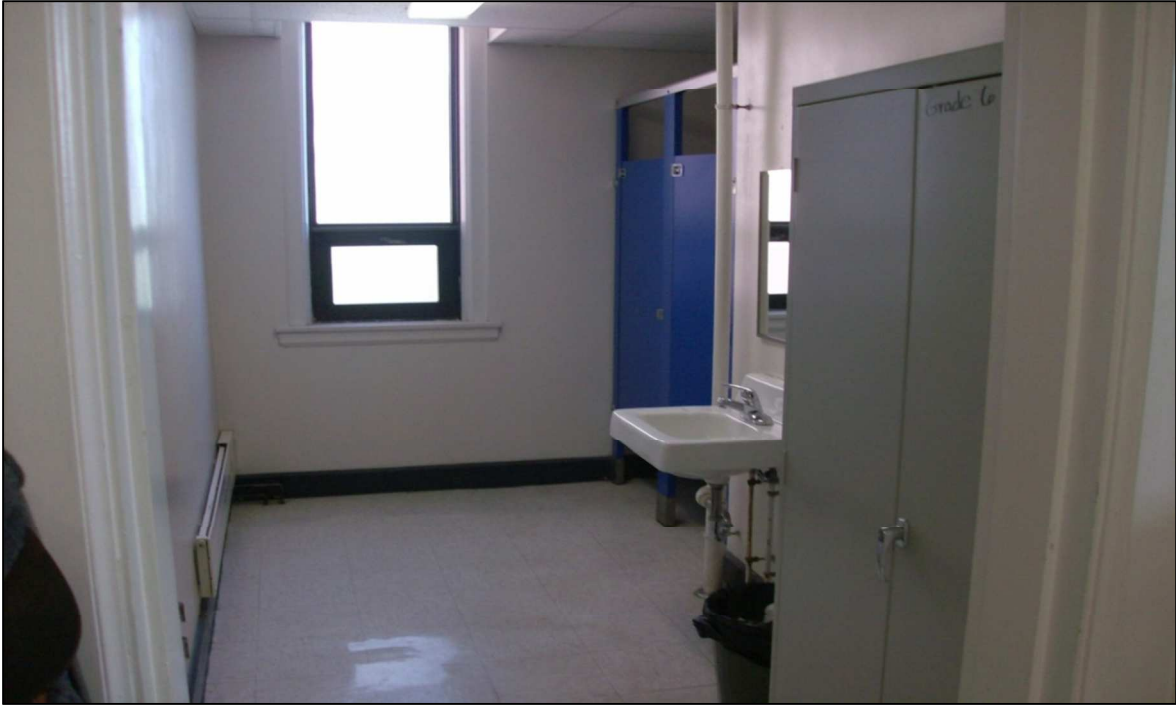
There is a shortage of ADA toilet compartments. Current codes require at least one accessible compartment in every toilet room where compartments are provided. Only two bathrooms in the 1997 addition comply. There are three toilets shown to be accessible on the 1997 addition drawings; however, they do not meet current accessibility guidelines.

Typical bathroom in 1945/1950 addition. There is a lack of fully accessible stall.
