EVALUATION AND ASSESSMENT
EMERSON ELEMENTARY SCHOOLS
27 RHODODENDRON ROAD
FITZWILLIAM, NEW HAMPSHIRE

NOVEMBER 29, 2017

Monadnock School District
Emerson Elementary School
27 Rhododendron Road
Fitzwilliam, New Hampshire

Facility Assessment

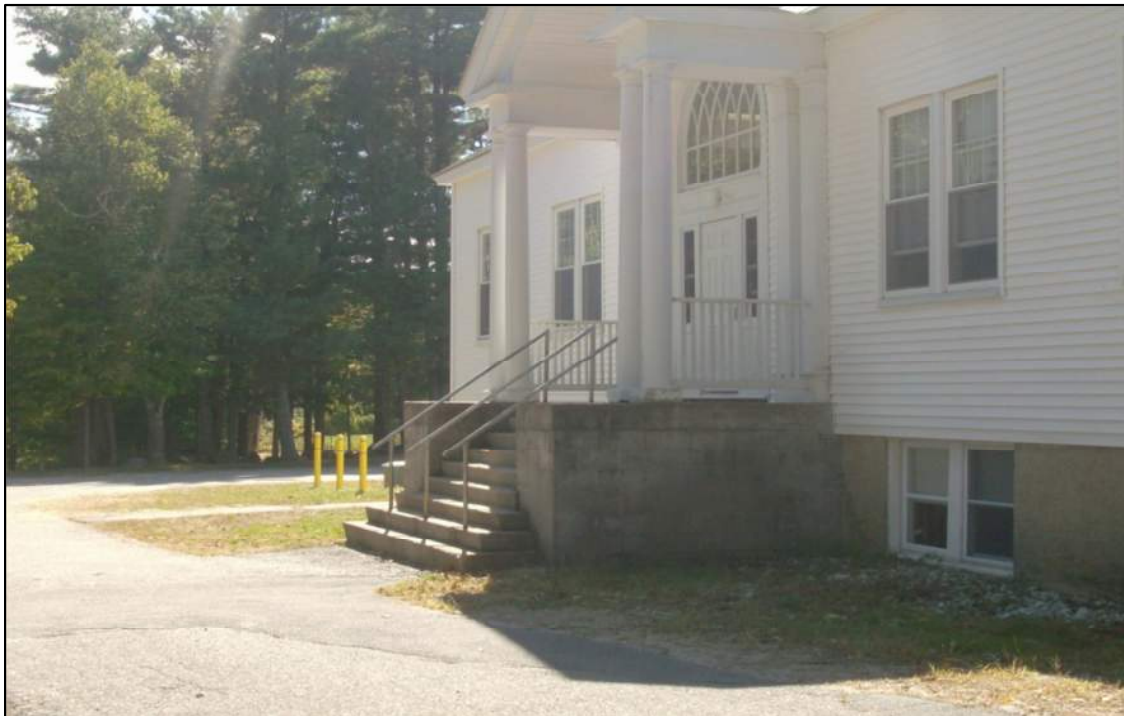
The original main entry to the school on the west side has a set of concrete stairs. The stairs are very steep and shallow and do not comply with current code for acceptable rise and run dimensions. Although this entry is no longer used for access into the building, it does serve as an emergency egress path. Eventually the stairs should be reconfigured to meet code requirements.

Former main entry on east side. Stairs are non-compliant.

- Reconfigure entry stairs on west side of building (i.e. original entry to school) \$100,000 to \$120,000
- Add new boiler in 1999 wing to supply ERV’s and eliminate long runs of piping from original boiler room..... \$125,000 to \$150,000

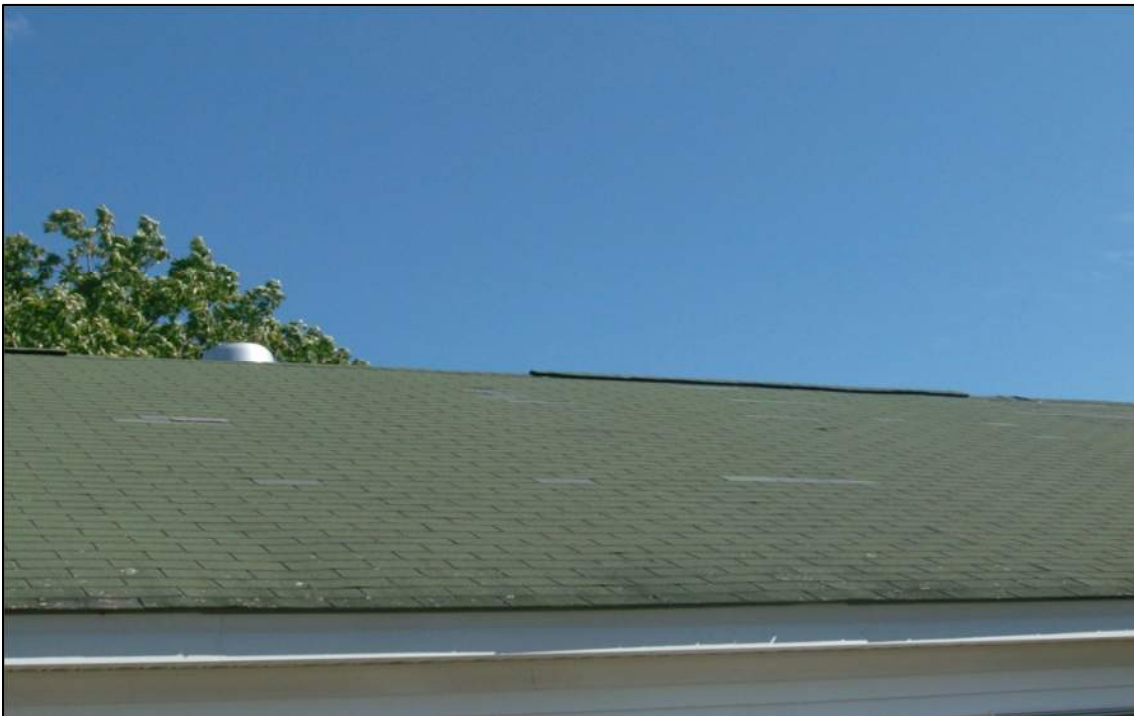
top of the shingles. The three tab style shingles are in poor condition as we observed missing shingles, mildew staining and lichen growth. We estimated that approximately 20,000 square feet of roof shingles will require replacement in the next 4 to 5 years. There is faux standing seam EPDM membrane roof over the chair storage room that appears to be in good condition; however some of the glued-on seam strips are missing.

Most of the roofing needs to be replaced.

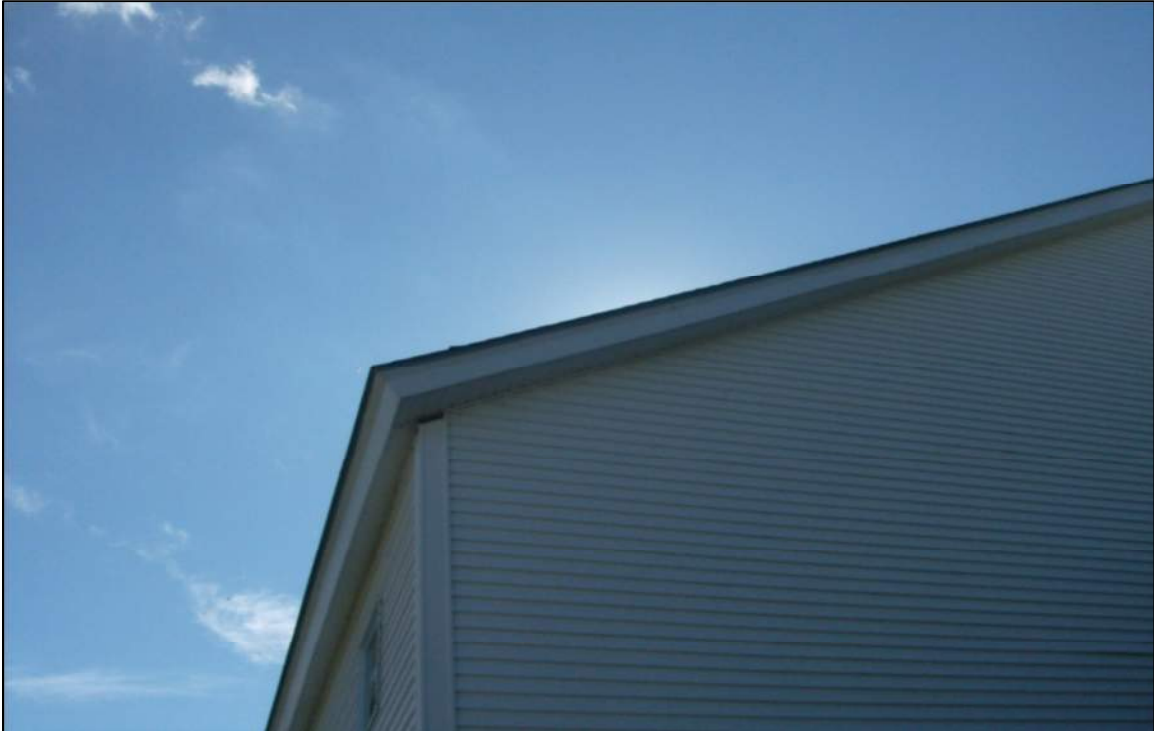
The exterior of the school is sided with vinyl clapboard siding, vinyl corner boards and soffits. The fascias and rake are clad in aluminum. There are a few areas where the clapboards are cracked, particularly along the bottom, most likely from landscaping equipment or in some cases from snow removal. There is also some evidence of mildew growth along the bottom edges of the north facing gym walls. In general, the siding is in very good condition. On the north side of the building at the corner of the multi-purpose room, the corner board has dropped a few inches and there is an open gap. This should be repaired to prevent the intrusion of water, insects, etc.

Gap in trim on north side allows water to penetrate.

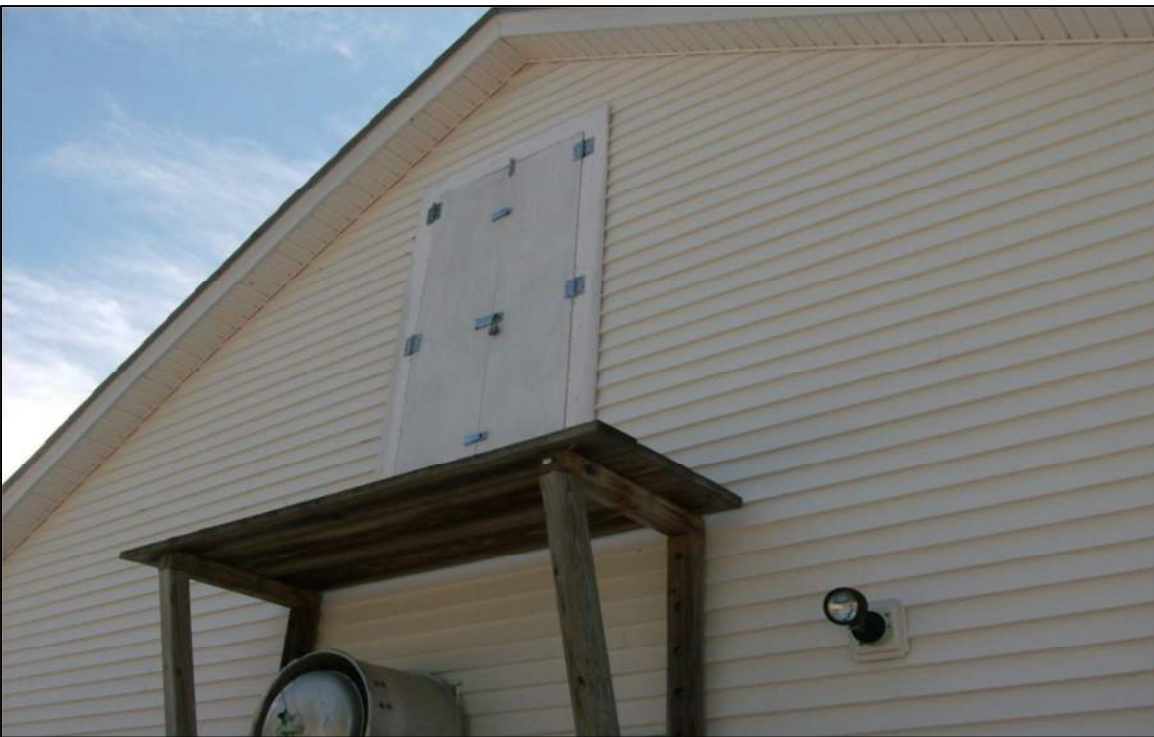
On the north side of the kitchen there is an elevated wood framed platform in front of a set of double doors supported off the gable end of the building. The double doors provide access into the attic space in order to service some mechanical equipment over the kitchen. The wood platform has no permanent stair or ladder access and does not have any guardrails around the perimeter. This entire means of access into the attic should be re-designed with personnel safety in mind.

Platform to access HVAC unit over kitchen. No handrail makes this particularly dangerous.

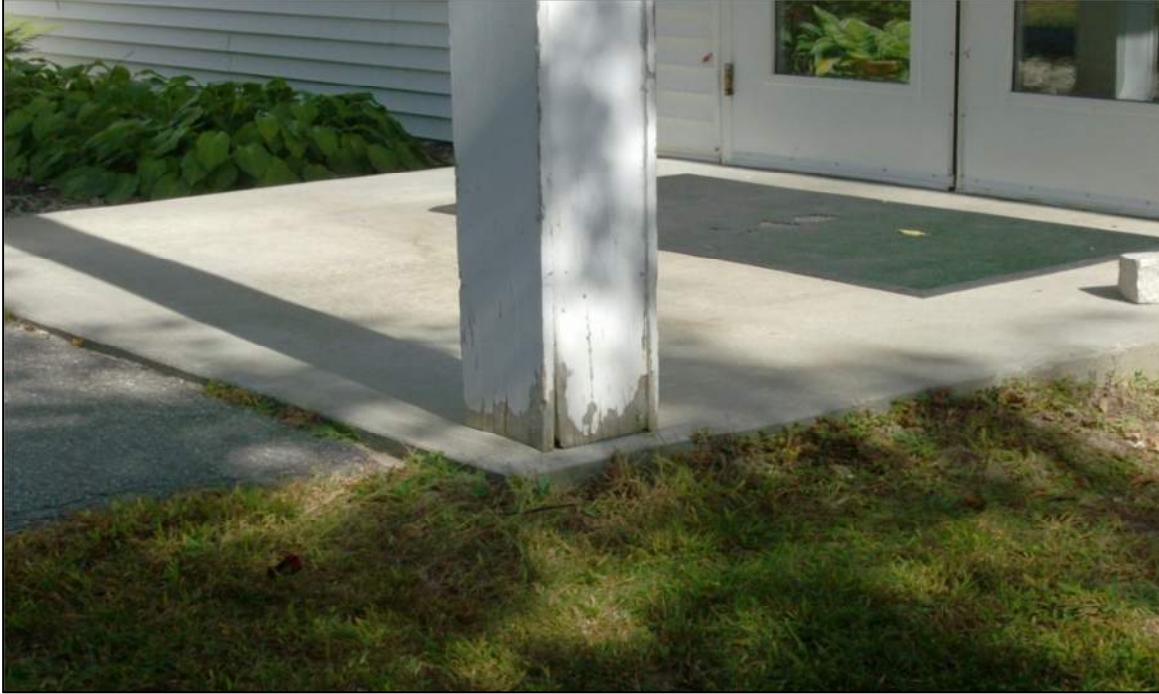
There was daylight visible between the door leafs of the main entry into the vestibule on the north side of the building. There were also gaps along the bottom of the doors. The astragals and weather seals should be replaced to help prevent cold air from infiltrating the vestibule. There is an entry door on the east side of the building just to the south of the multi-purpose room. The paint on the wood posts that support the entry canopy is peeling at the bottom where the posts contact the concrete slab. The posts should be scraped and painted and any rotted sections of trim should be replaced.

Posts at west entrance needed paint and showed signs of wood rot.

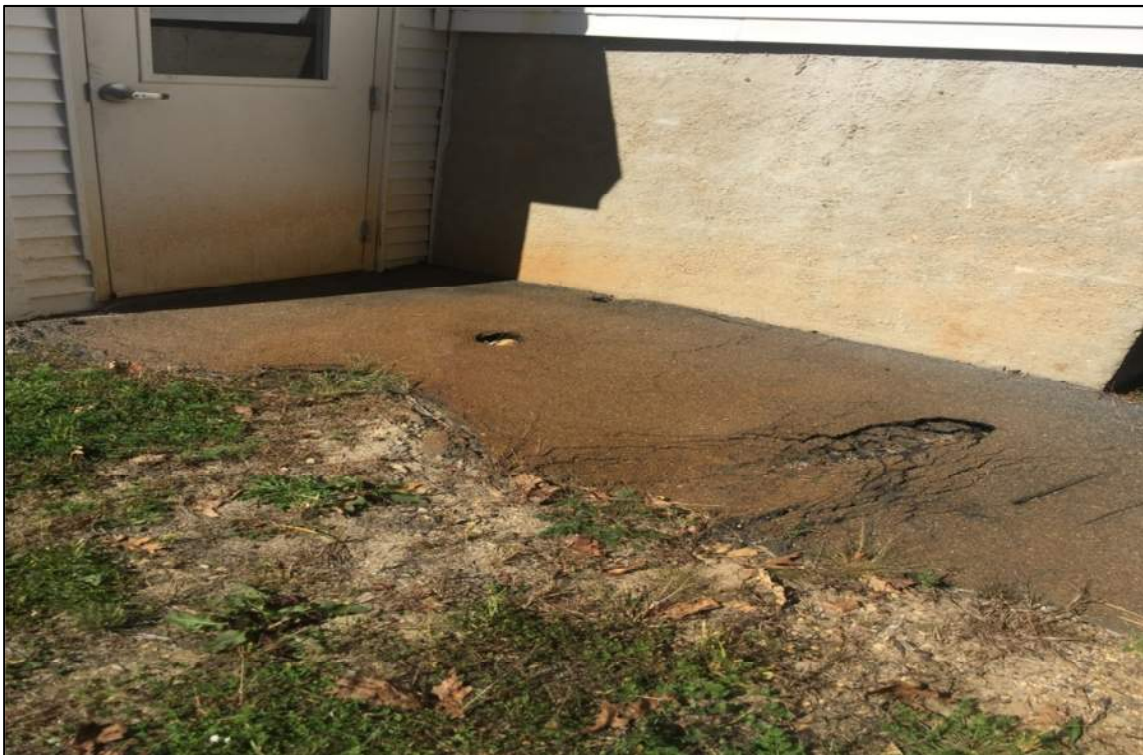
Door on east side is rusting and note poor condition of pavement.

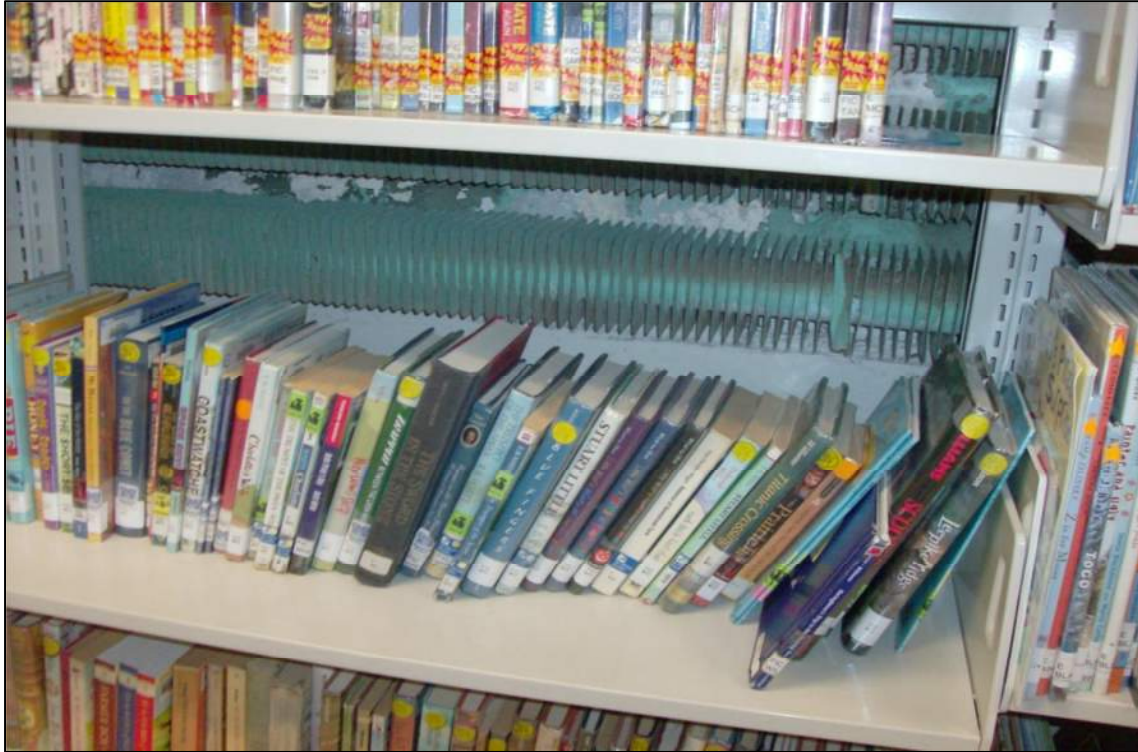
Heating in all but the 1999 addition to the school, including the corridors, is through hot water piping and fin tube radiators. In the classrooms, some of the fin tube is covered by shelving and bookcases which cuts down on its effectiveness. In the library there are fin tube sections behind some of the bookshelves. Even though an attempt has been made to limit the placement of books in front of the fin tube radiators, there is some blockage, reducing the efficiency of these units. In other locations there are dented or blocked covers that should be addressed for better air flow. The original boiler was replaced in 1987 with a three module, oil-fired boiler with three circulator pumps. Several years ago, the boiler was converted over to burn natural gas. Rooftop fans exhaust air from the bathrooms and classrooms, but there was a lack of fresh air supply to the original and 1990's addition.

Fin tube behind bookshelves of library.

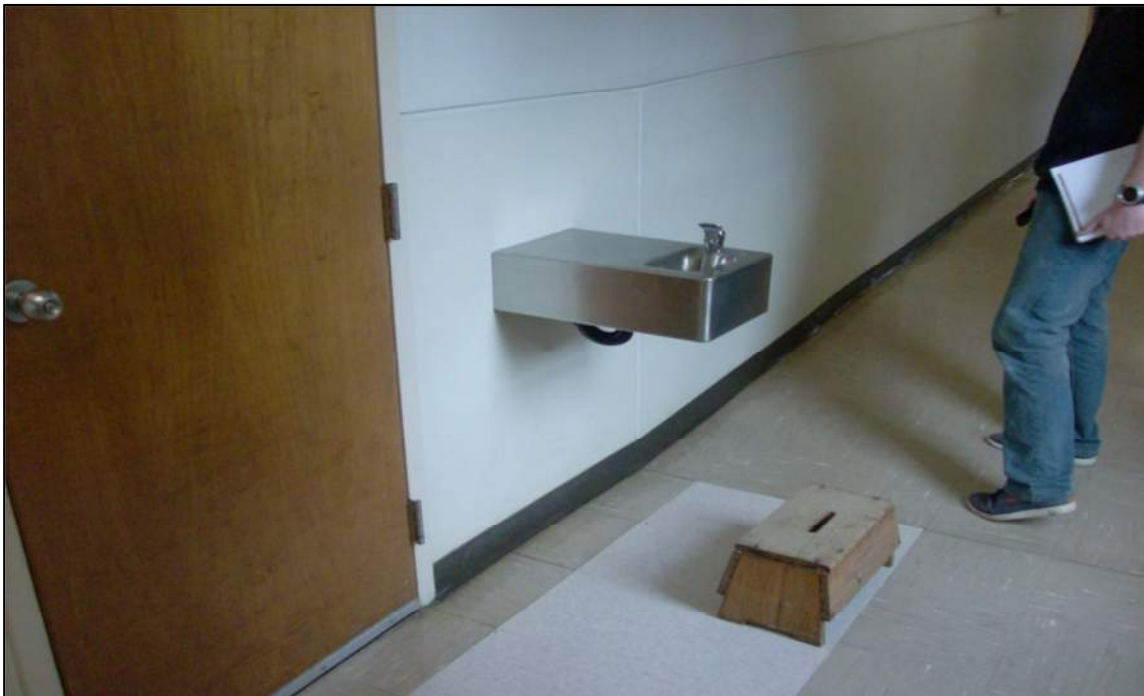
Drinking fountain extends out into corridor and creates an obstruction.

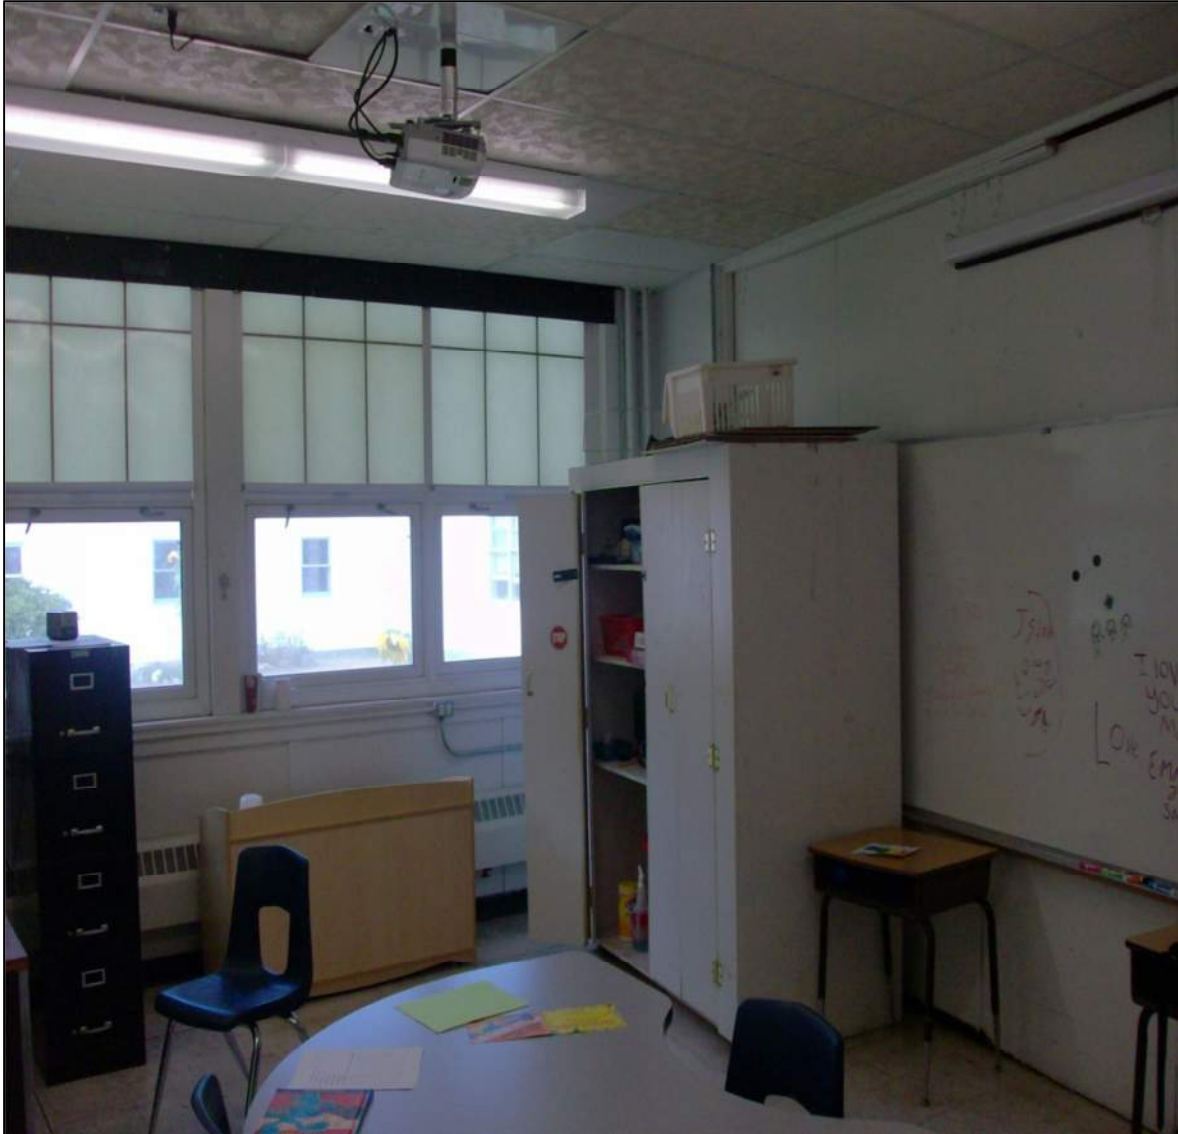
infill band of Kalwall directly above the window glass. The Kalwall panel extends up above the ceiling level and there is a gap between the ceiling panel and the window unit. The hopper-style windows are leaky and do not provide a good seal. These windows along with the Kalwall inserts should be replaced within the next 2 to 3 years. The Kalwall components can be replaced with an insulated metal panel and the window should be upgraded to a new energy efficient unit. The 1999 wing is a combination of vinyl double-hung windows, awning windows in the kitchen, and fixed style windows in the multi-purpose room. These windows are about 18 years old and the flashings, j-trim, etc., all are in good condition with no leaking or failed seals observed. These windows should be adequate for the next 8 to 10 years.

Old hopper-style windows with Kalwall panels above.

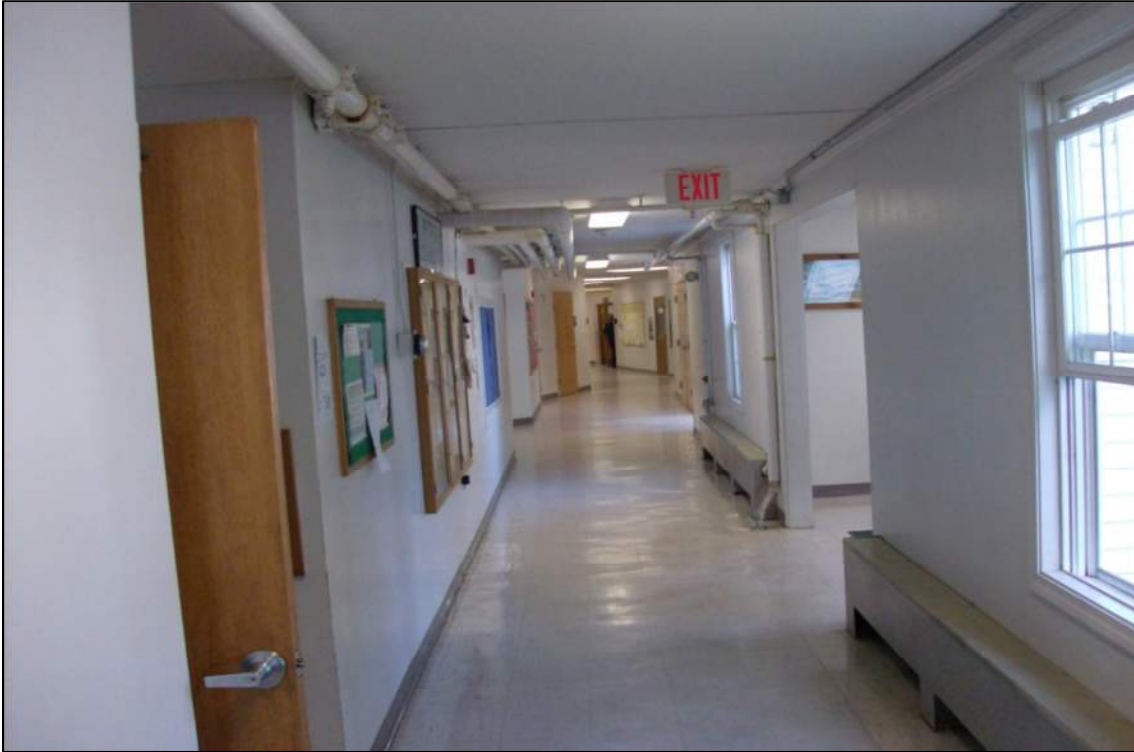
Hot water supply and return lines run from the original 1925 boiler room all the way to heating coils in the ERV ductwork, as well as to heating coils in ceiling mounted heaters over the entry doors of the new addition. Some of this piping hangs below the drop ceiling. It would be advantageous to locate a boiler in the 1999 wing to allow for removal of this unsightly piping that hangs below the ceiling.

Note exposed sprinkler and heating pipes below ceiling.

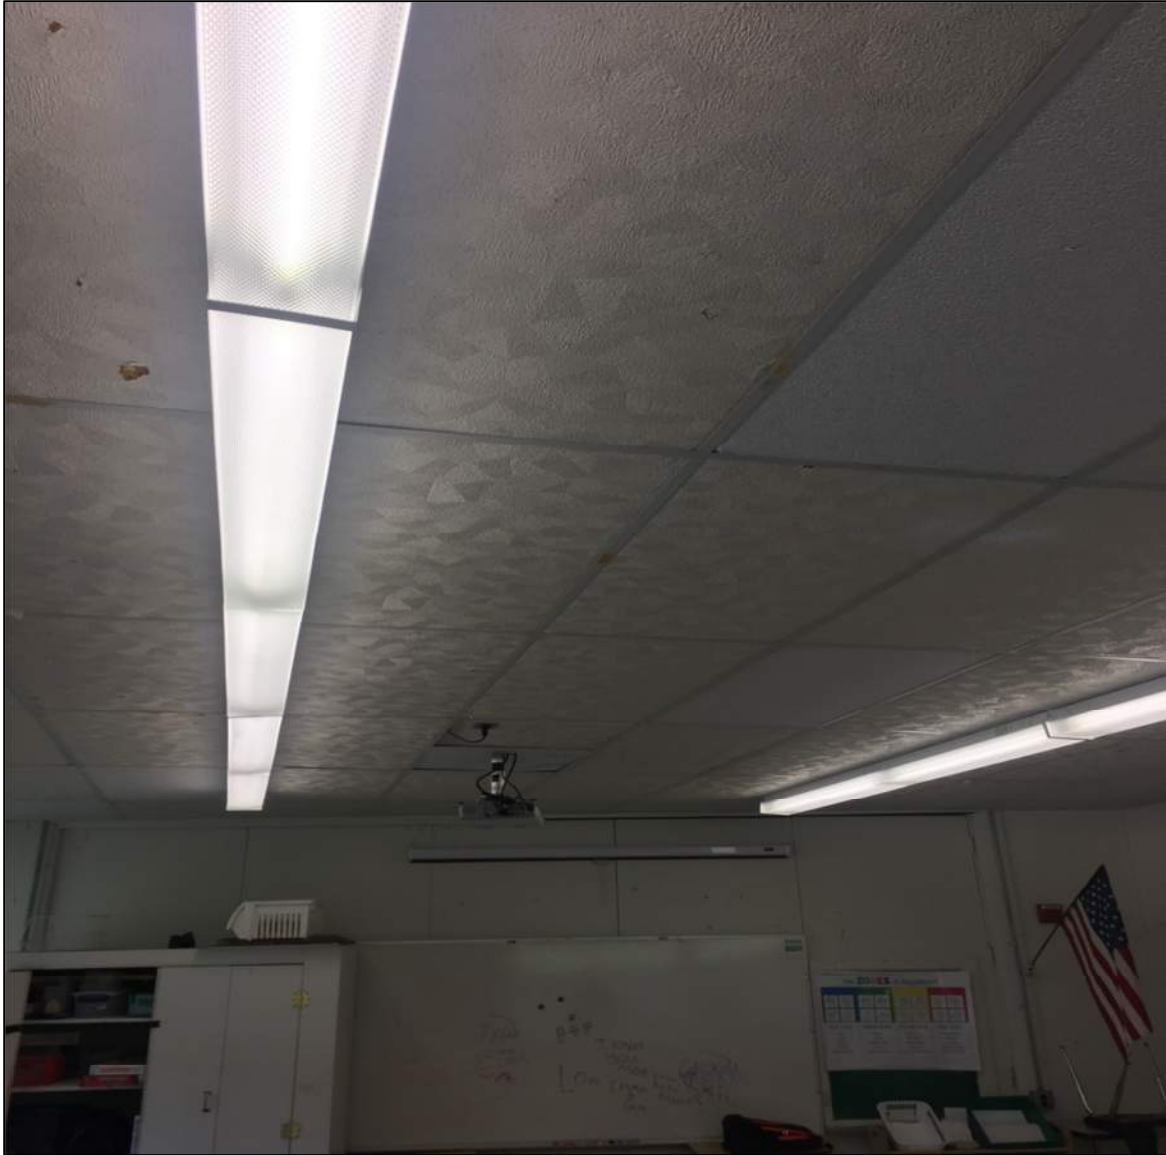
The ceilings throughout most of the educational areas are acoustical ceiling tile. The tiles are vinyl faced foam panels and standard fine fissured panels. The tiles are in fairly good condition with no excessive staining. We observed minor sagging in some of the 2 x 4 tiles. The classrooms in the newest addition have hard, gypsum ceilings. The tectum paneling in the multi-purpose room is in good condition.

Drop ceilings need to be replaced and upgraded.

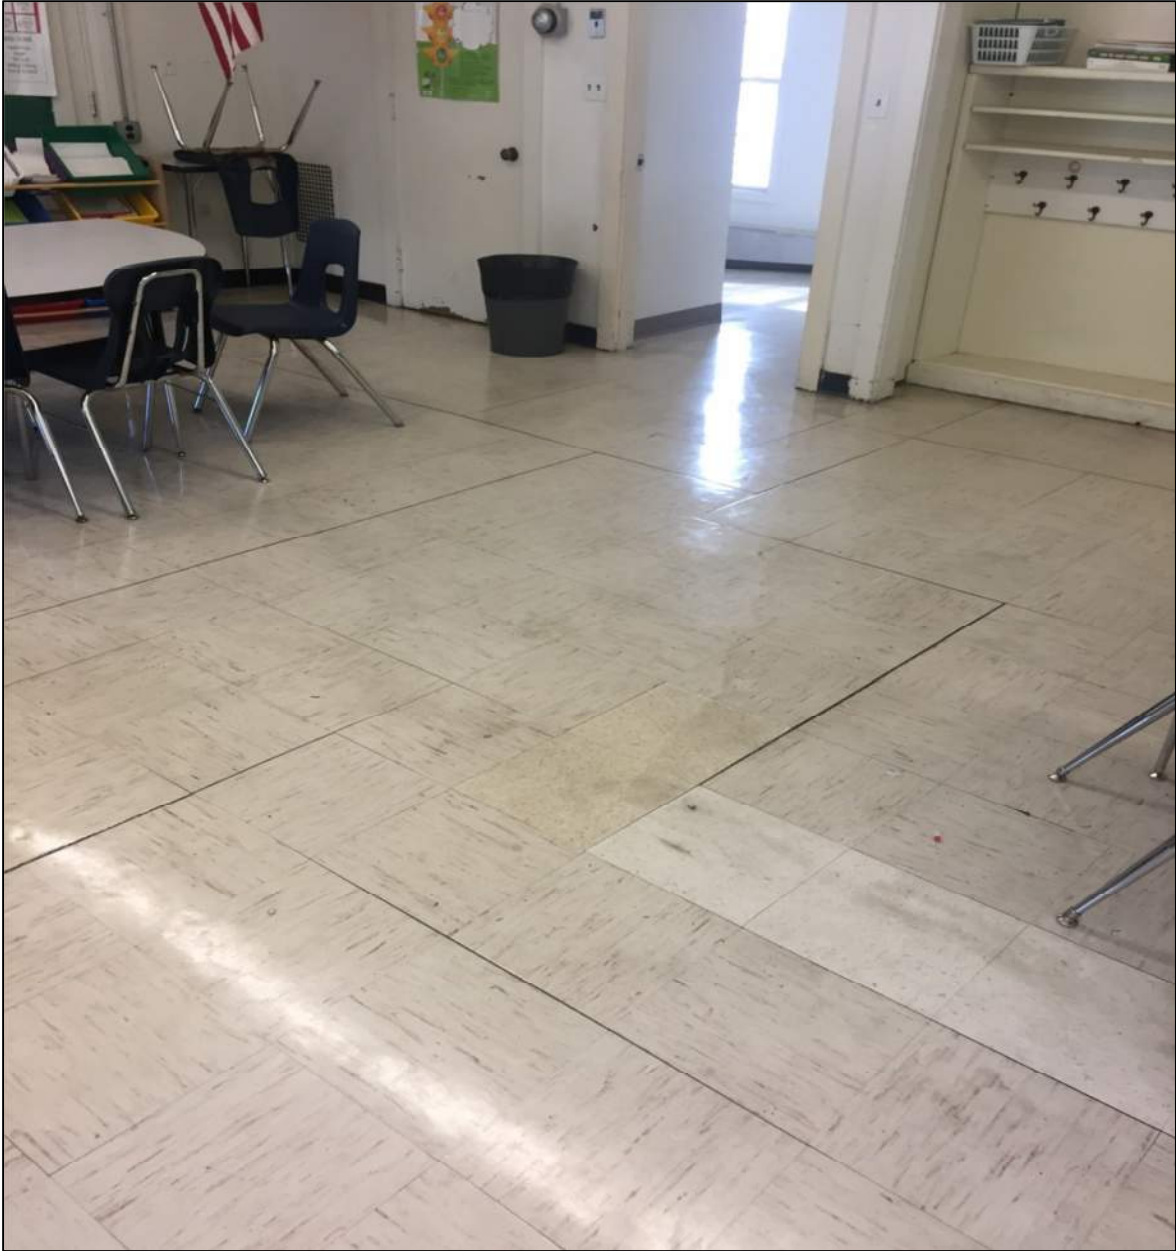
The floors are primarily covered with vinyl composition tile (VCT). The VCT is in fairly good condition throughout the building. One classroom in particular on the south side of the 1999 addition, has large gaps between some of the floor tiles. Other tiles have been replaced within this same classroom indicating an issue with slab movement or slab cracking. This should be further investigated before the floor is replaced. We observed some cracked tiles in the storage room of the multi-purpose room. The tile in the mechanical area of the original wing has seen frequent water, based on heavy staining observed in this area. The staff areas have carpeting, which was in fair condition with typical wear patterns in high traffic areas. The carpeted areas should be replaced in the next five years. The bathrooms in the original wing has ceramic tile which is in good condition other than needing cleaning in some spots.

VCT flooring in 1950's addition. Note gaps in tile and past areas of tile replacement.

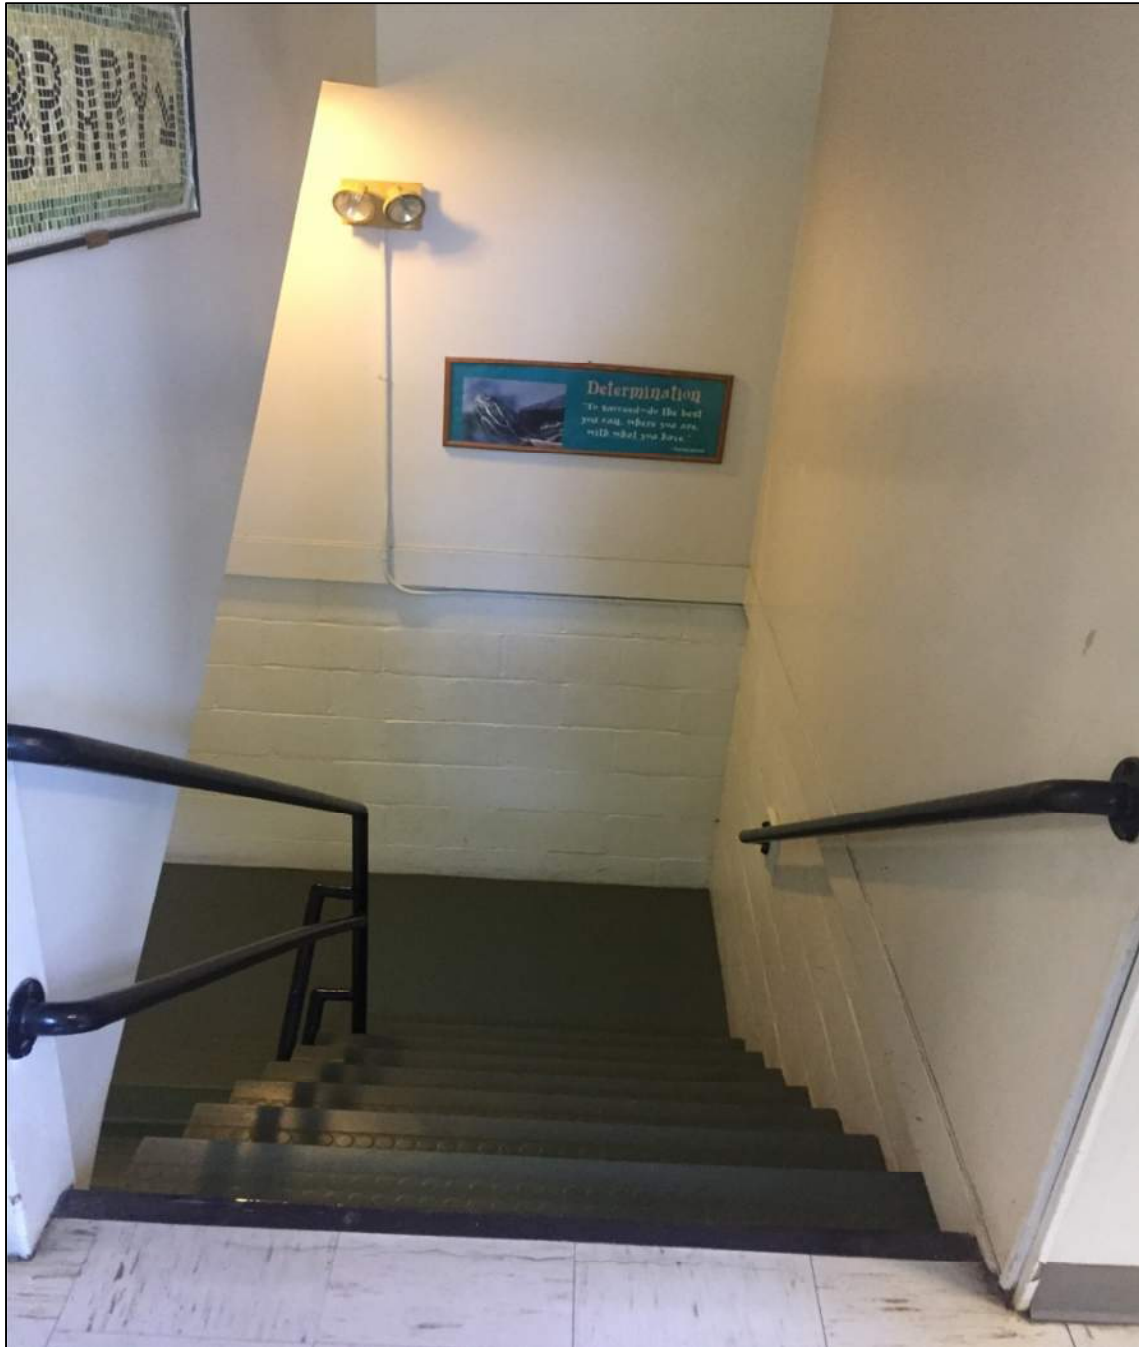
From the main corridor there is a set of stairs that lead to the lower level to the library and some offices. The stairs are wood framed with vinyl risers and treads, which are in good condition. The stair guard railings do not comply with current code requirements in terms of height and baluster opening requirements. Also, they do not provide the current code required extensions at the top and bottom. The railings on this stairway should be upgraded in the next 2 to 3 years.

Stairway into basement with non-compliant handrail.

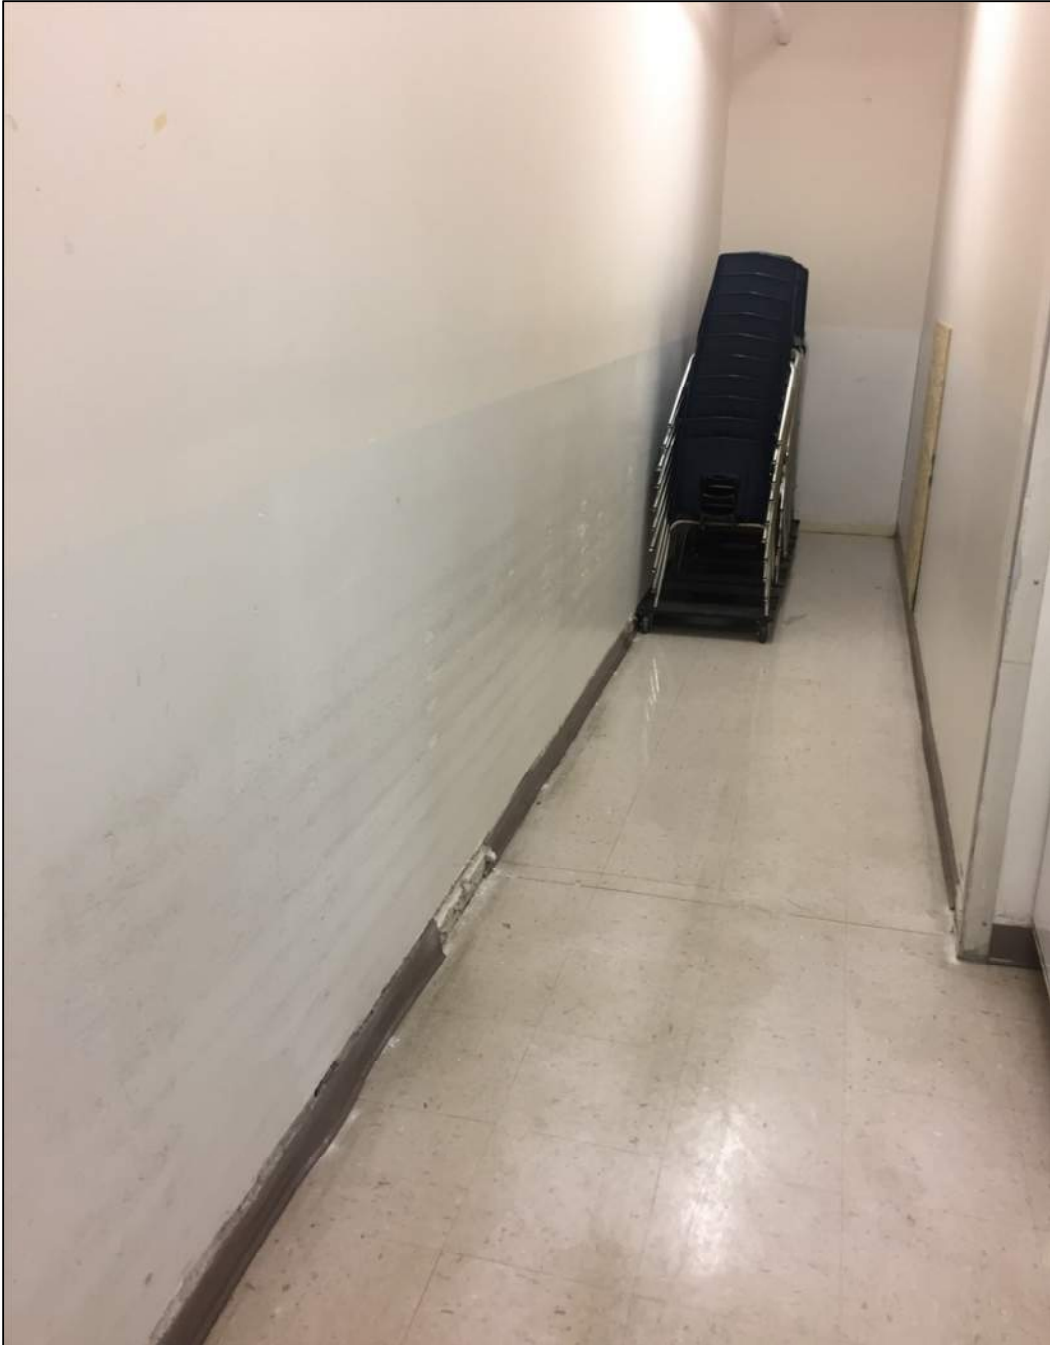
Area adjacent to Gym used for storage of chairs. Note damaged walls and baseboard.

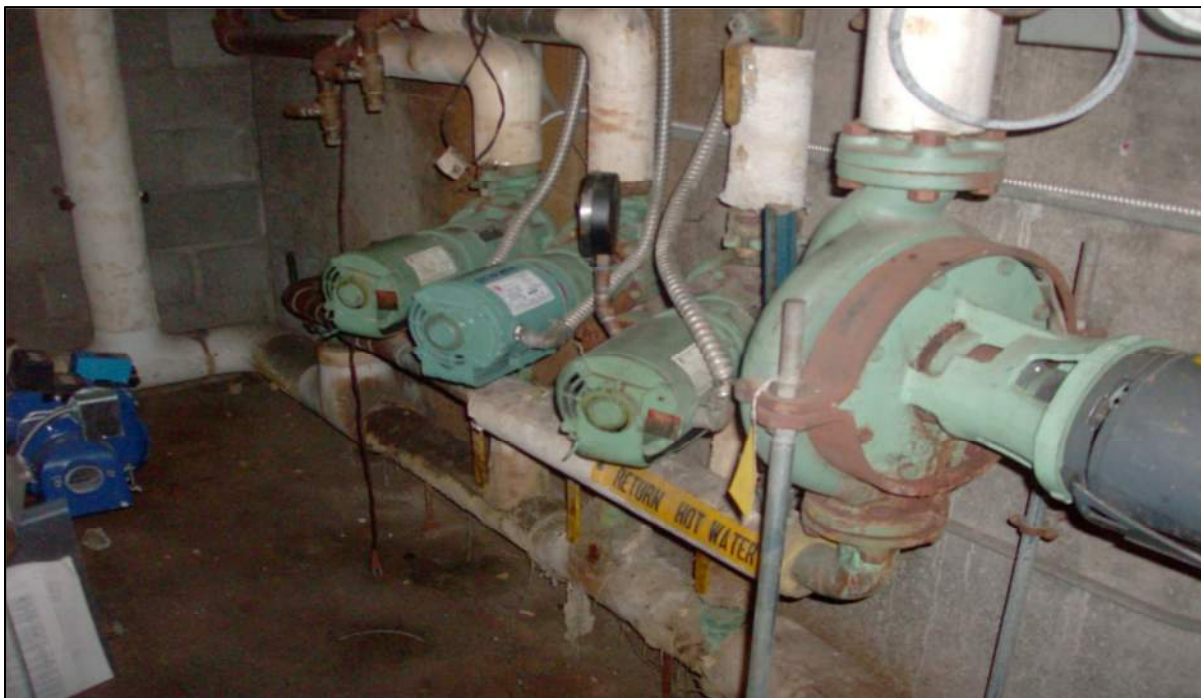
Two of three circulating pumps should be upgraded.

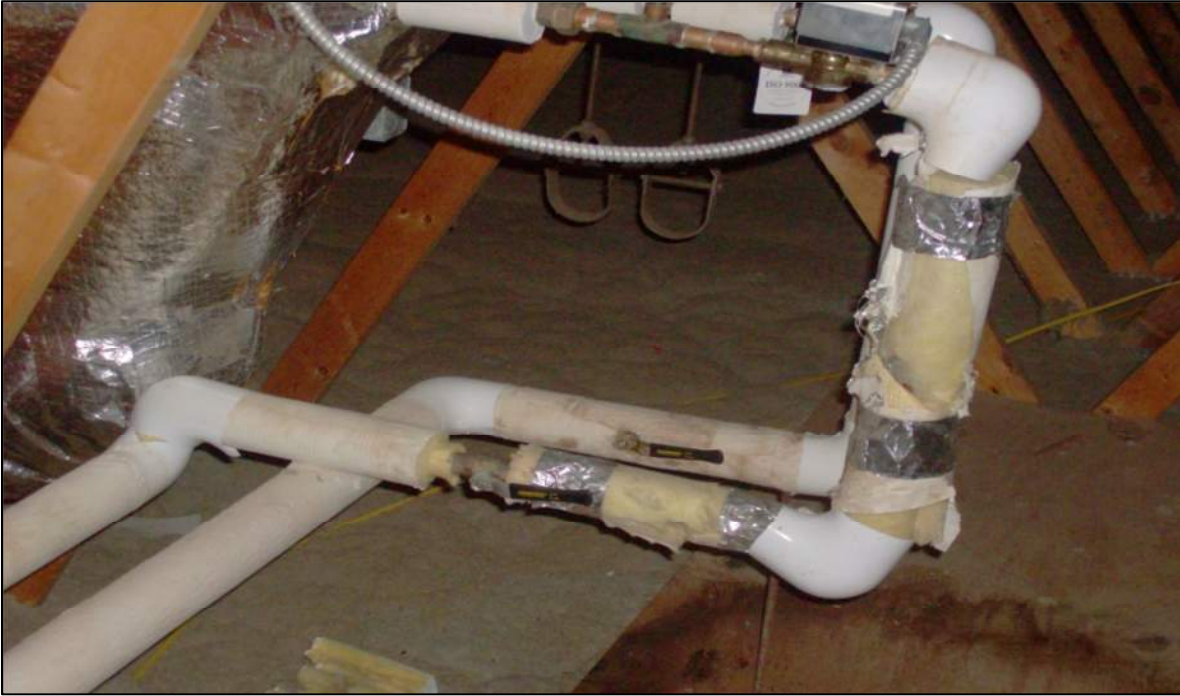
Section of heating piping in attic with no insulation.

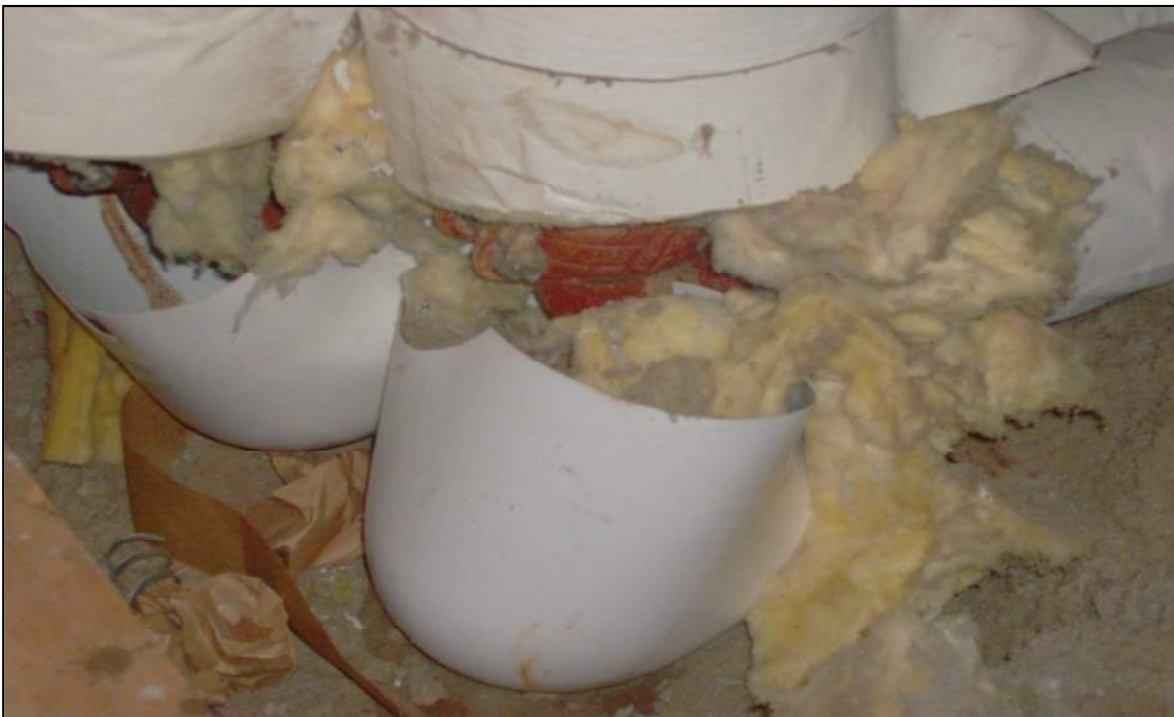
Original pipe insulation removed, but not properly replaced.
