EVALUATION AND ASSESSMENT GILSUM ELEMENTARY SCHOOLS 640 NH ROUTE 10 GILSUM, NEW HAMPSHIRE

OCTOBER 20, 2017

The H.L. Turner Group Inc.

Facility Assessment

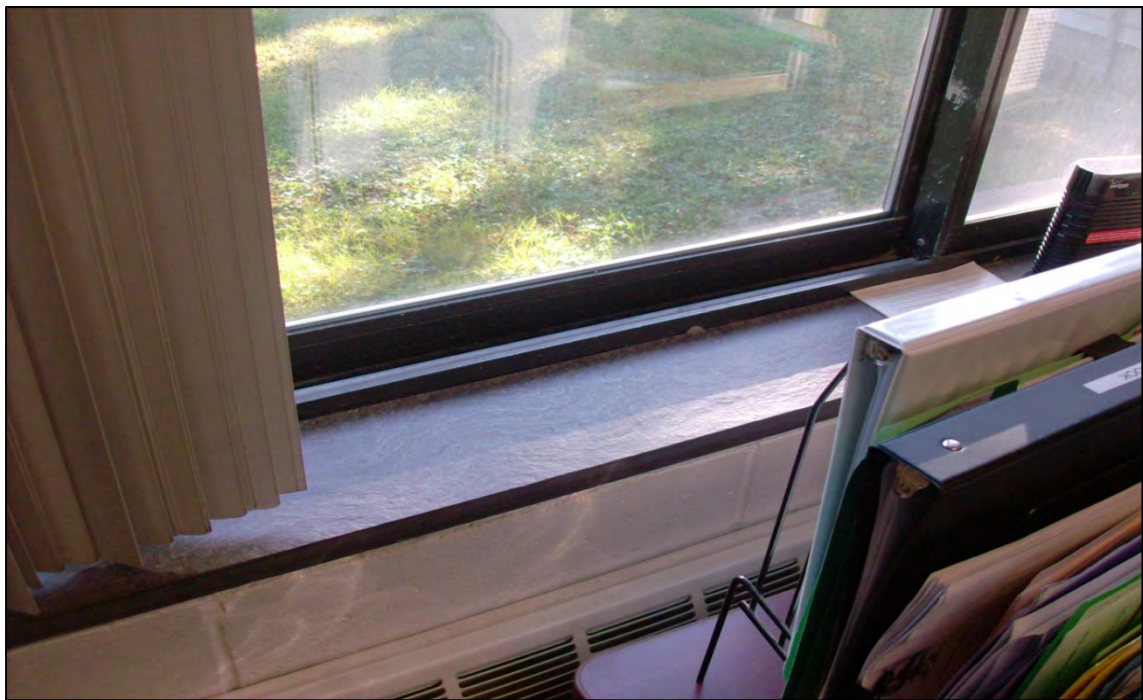
The windows in the 1970's wing are metal clad sliding window units that appear to be nearing the end of their useful life. These include windows in the classrooms as well as the windows in the administrative offices. Exterior joint sealants need re-touching in some areas. The windows in the original section of the building have been replaced with vinyl units and are in good condition. The windows in the 1995 wing are wood windows with vinyl cladding on the outside. These windows appear to be in good condition. The windows in the 1980's wings are double-hung, wood windows and these are in good condition as well.

Typical casement type metal windows in 1970's wing in need of replacement.

- Install new windows in the 1970's wing which included classrooms 1 and 2, the administration offices, and improve wall insulation (\$30,000).
- Replace doors and frames in rooms 1 and 2 (\$4,000).

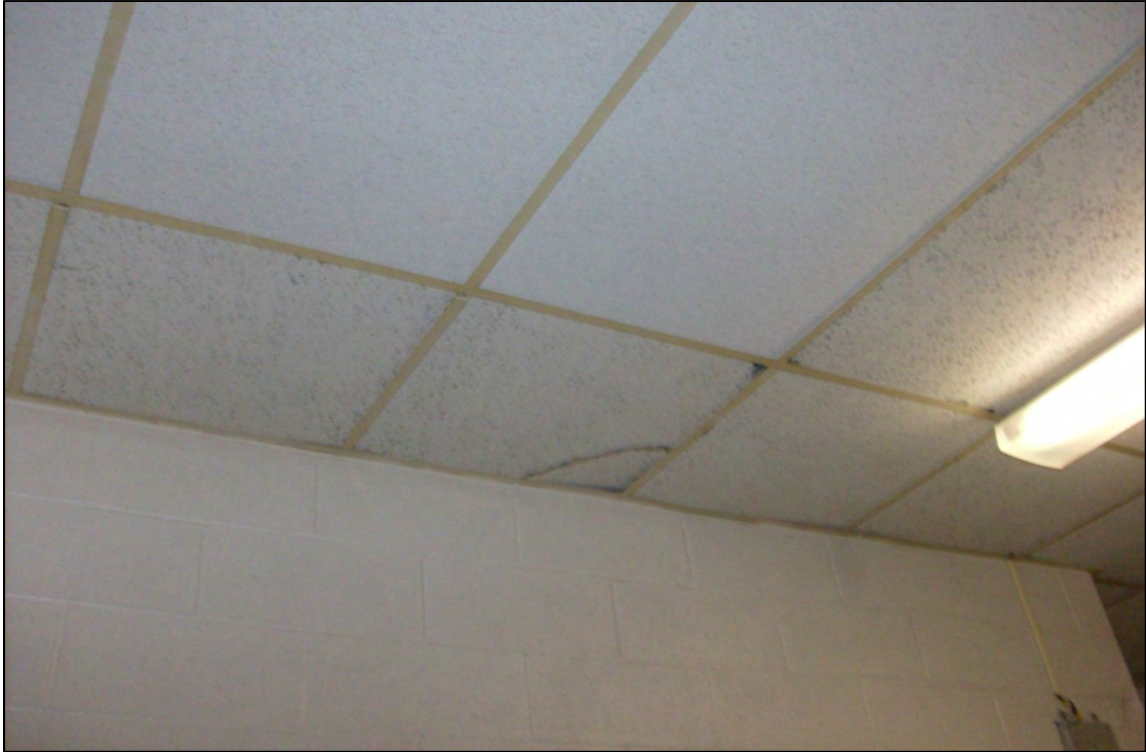
The ceilings consist mostly of acoustical ceiling tile (ACT) throughout the educational areas. Many of the tiles are cracked, sagged, or have areas of staining. Most of the ceiling tile throughout the building, with the exception of the 1990's wing should be replaced. The tectum and wood paneled ceilings in the gymnasium are in good condition.

Discolored and cracked ceiling tile, typical in many locations.

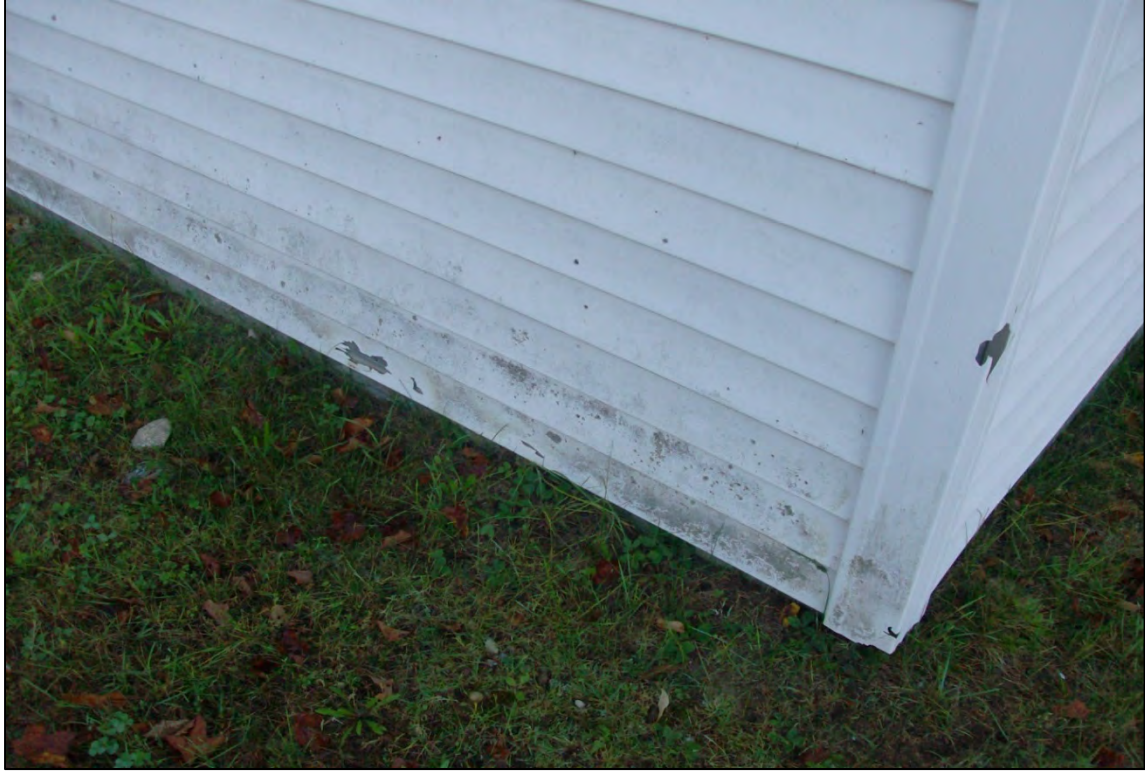
The exterior of the school is sided in a combination of split-rib CMU on the 1970's section, wood clapboards on the 1995 addition, and vinyl clapboards on the 1980's addition and the original building. There is mildew growth on the north and east facing walls and other areas that do not receive adequate sunlight. On the sidewall of the dining room within the courtyard there is an area of water damaged clapboards.

Mold growth on vinyl siding. Damage from “weed whacker”.

- Replace the roof shingles on the entire building (approximately 166 square feet at \$400 per square for materials and labor = \$66,400).
- Clean the siding of mold and mildew (\$1,000).

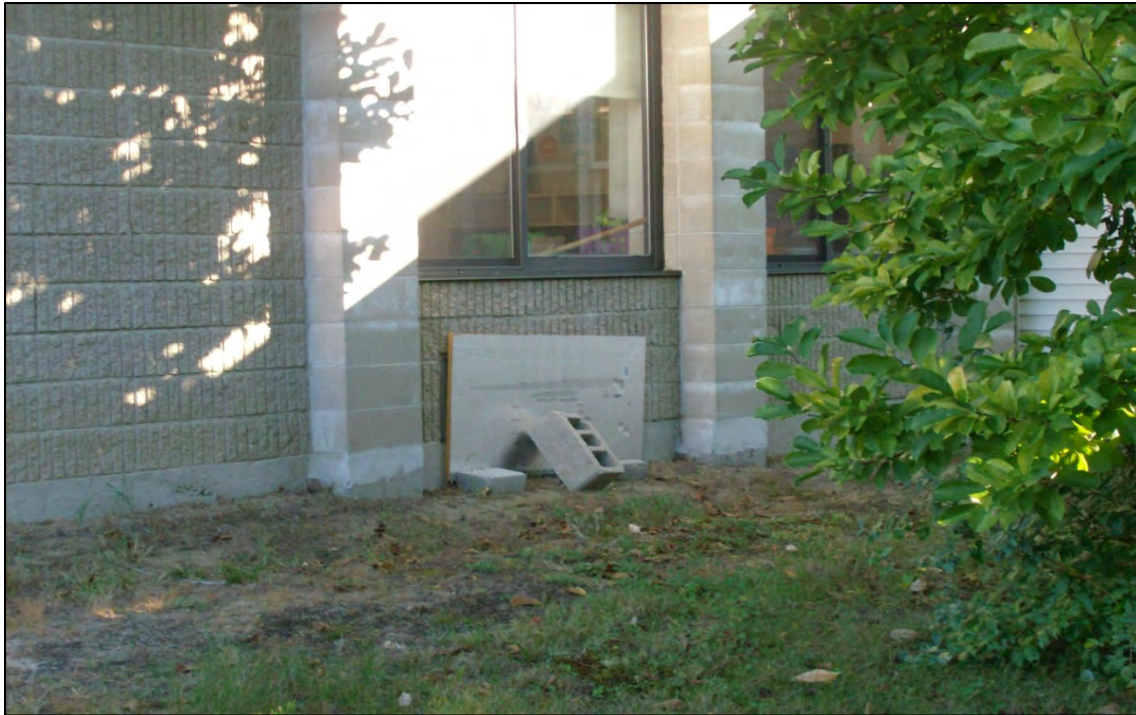
There is a large 8,000 CFM Air Handling Unit over the stage area for supplying the gymnasium, along with a large centrally located exhaust fan. The corridors of the newest wing have ceiling mounted cabinet unit heaters, and the dining area has fin tube heaters and unit ventilators supplied with hot water from the boiler room. The heating system in this newest addition is in good working order. The unit ventilators in the 1970's wing are beyond their useful life and should be replaced. Some of the exterior air intake grills have been blocked with foam panels up against the outside of the building. This has been done in an attempt to block cold air from entering the unit up into the building as the unit

dampers are no longer functional. The remainder of the building was heated with hot water baseboard type heaters and they reportedly were satisfactory. Other than the gymnasium, the building does not have a fresh air intake. We did observe some exhaust air ducts pulling air from the bathrooms, but in general more building wide ventilation is needed. Any system installed should take advantage of capturing the energy in the exhaust air through an energy recovery ventilator. Temperature swings throughout the building due to poor HVAC system operations was mentioned during our site visit. Install a new, expandable control system that controls the equipment globally with remote access of set points and alarms. Ideally, for the long-term, consideration should be given to incorporating air conditioning into any new system being considered for the building.

Unit ventilator grille blocked with foam panel.

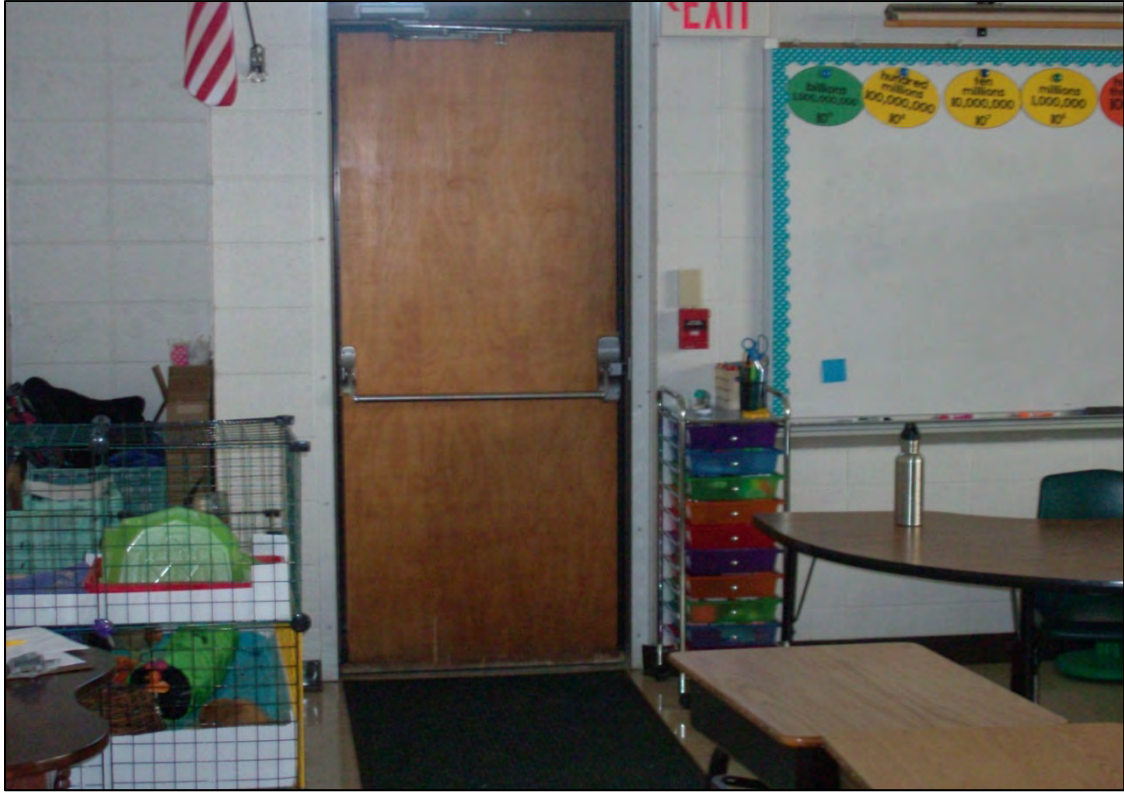
It was reported that the two west facing doors of classrooms 1 and 2, in the 1970's addition, leak quite heavily during a driving rain. Water puddles on the floor inside the door. Apparently some new seals have been installed, but this has not completely solved the problem. This should be further investigated to determine the cause and addressed to

extend the life of the floor and door itself. It may be that the doors may require replacement.

One of two doors that leak during driving rains.

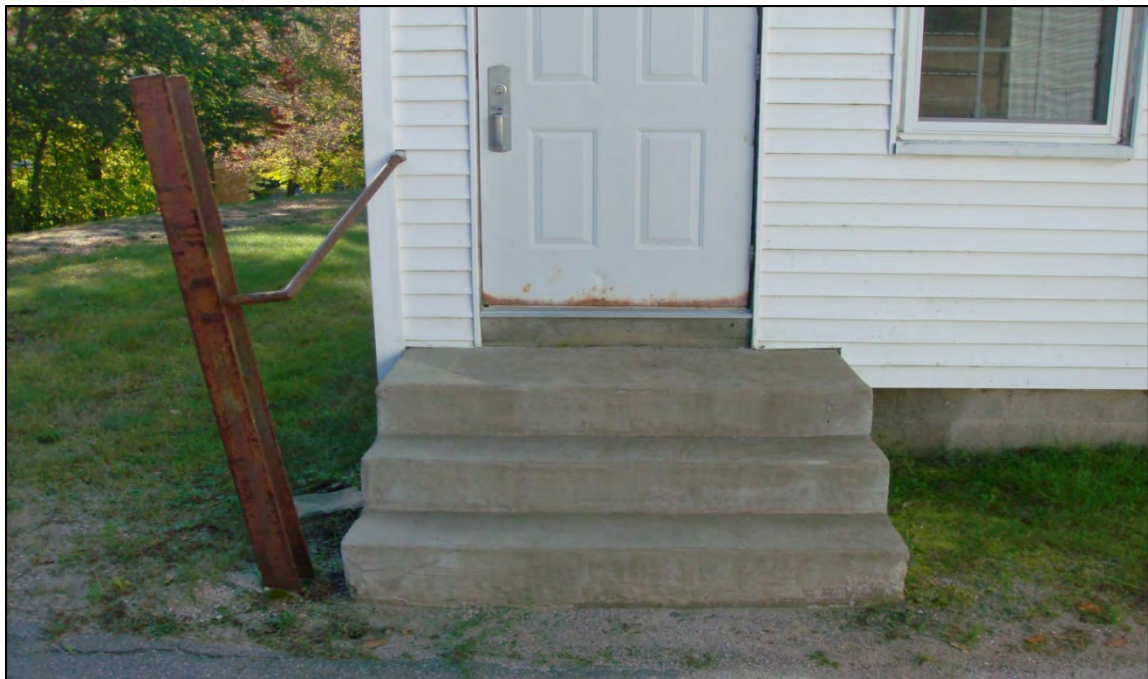
On the north side of the music room (one of the original classrooms) the door is rusted along the bottom and should be repainted. The handrail on the stair is badly rusted and is not constructed per Code. The steel end post had been hit by a vehicle and was out of plane.

Door at Music Room. Door needs painting and railing should be replaced.

- Seal gaps under window sills or install screening so they are insect proof (\$1,200).
- Repaint the rusted door at the music room (\$300).
- Investigate basketball hoop in gymnasium and determine if there are structural issues preventing it from being retracted (\$1,500).

- Replace the fire alarm system (\$40,000 to \$50,000).
- Replace railing on exterior stairway at music room (\$3,000 to \$4,000).
- Reconfigure the roof canopy over the door on the east side of the building to improve the shedding of water and install new roofing (\$4,000 to \$5,000).
- Replace all light fixtures with new LED energy efficient fixtures and sensor switches. (\$125,000 to \$150,000).
- Improve air flow in basement area and improve dehumidification of the space (\$15,000 to \$20,000).
- Install school wide air conditioning (\$200,000 to \$250,000).

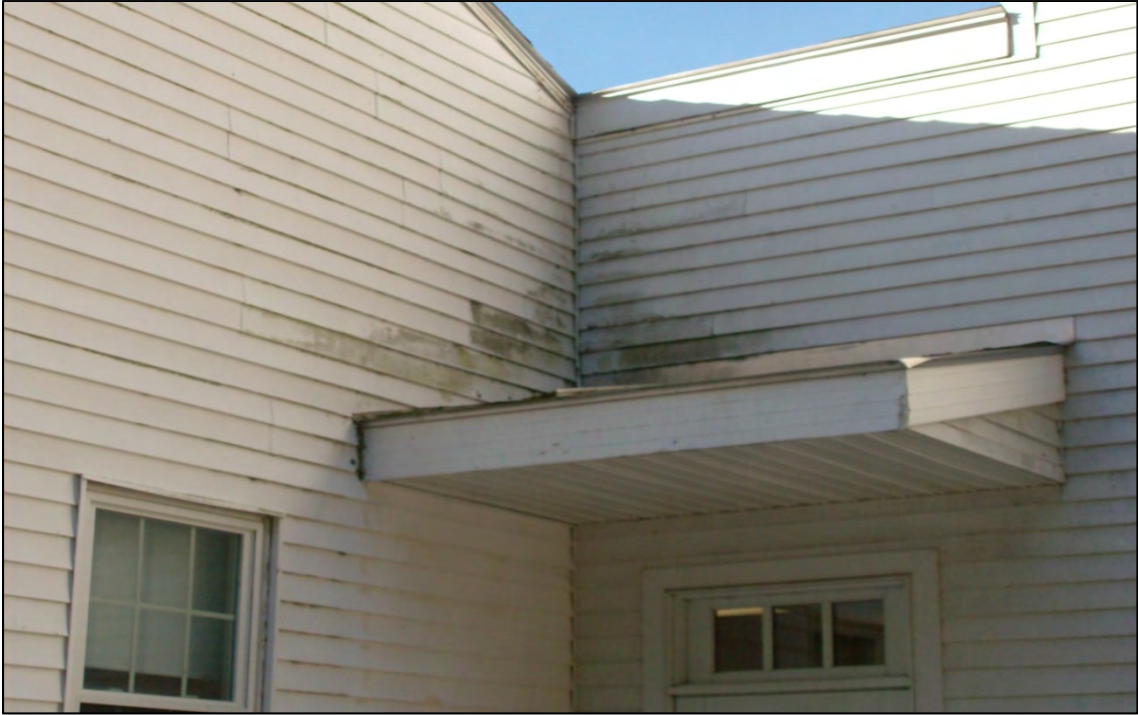
Canopy over door on east side. Note mildew and rotted siding.

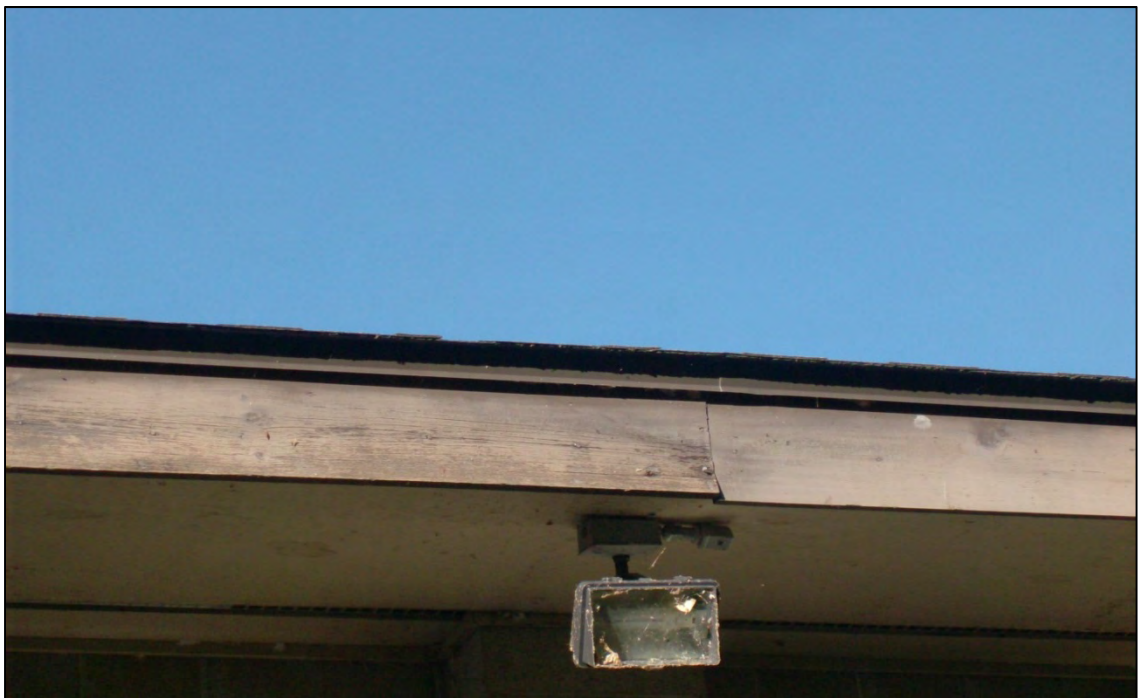
The soffit and fascia trim of the 1970's portion of the building is badly peeling and needs repainting. Some boards are rotted and need replacement. An alternative to repainting is wrapping the trim in break metal. We also observed the fascia trim splice joints around the 1995 addition are separating and need to be covered with a cap piece to seal the joint from water penetration.

Fascia board on 1970's wing needs paint or break metal covering.

- Scrape and paint wood trim on the 1970's wing or wrap the fascia in break metal (\$3,000).
- Exterior of building; general exterior painting (\$5,000).

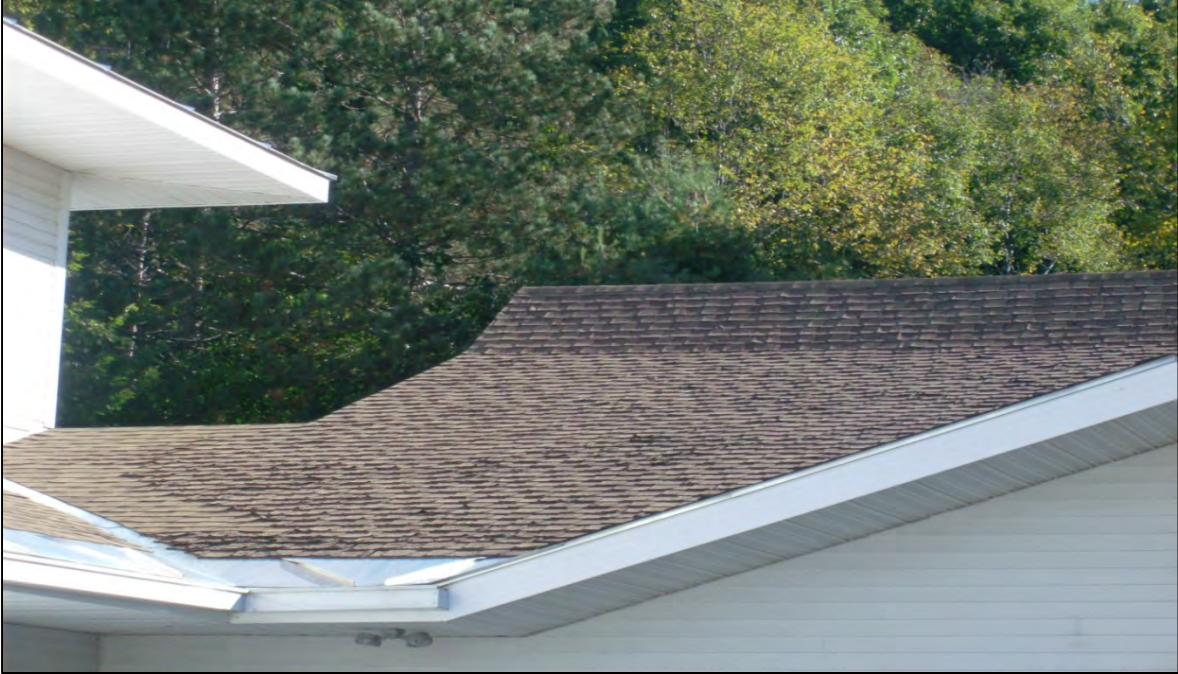
All the roofs are covered with an architectural shingle. As observed from the ground, many of the shingles, particularly on the south and west facing sides, are curling, are in poor condition, and appear to be in need of replacement within the next two to three years. The shingles on the north and east sides did not exhibit this curling, but all the shingles should be replaced at the same time. On the east side of the building adjacent to the music room there is an exit from the corridor of the 1995 wing. There is a small canopy roof over the door and the siding adjacent to this canopy roof had heavy mildew staining and possibly some rot. It is apparent that this canopy roof needs better water/snow shedding capabilities to help prevent this staining and deterioration of the wood.

Poor condition of roof shingles on west side near courtyard.

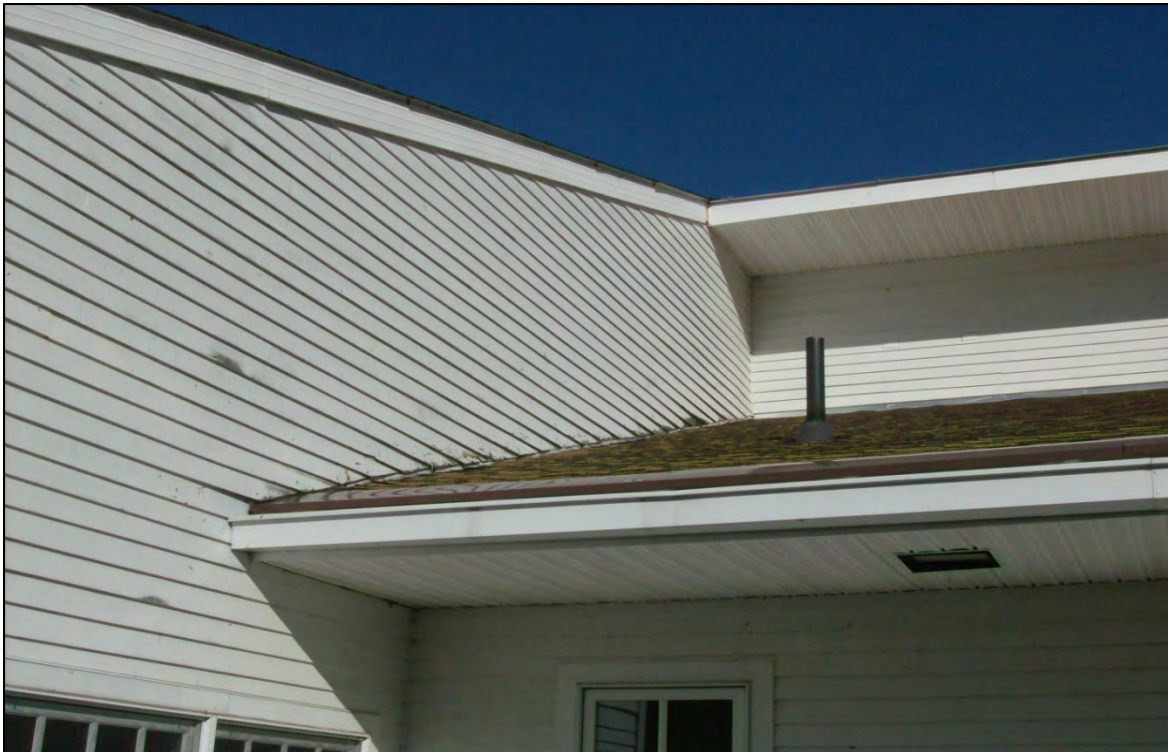
Roof at courtyard. Note rotted siding along slope of roof.

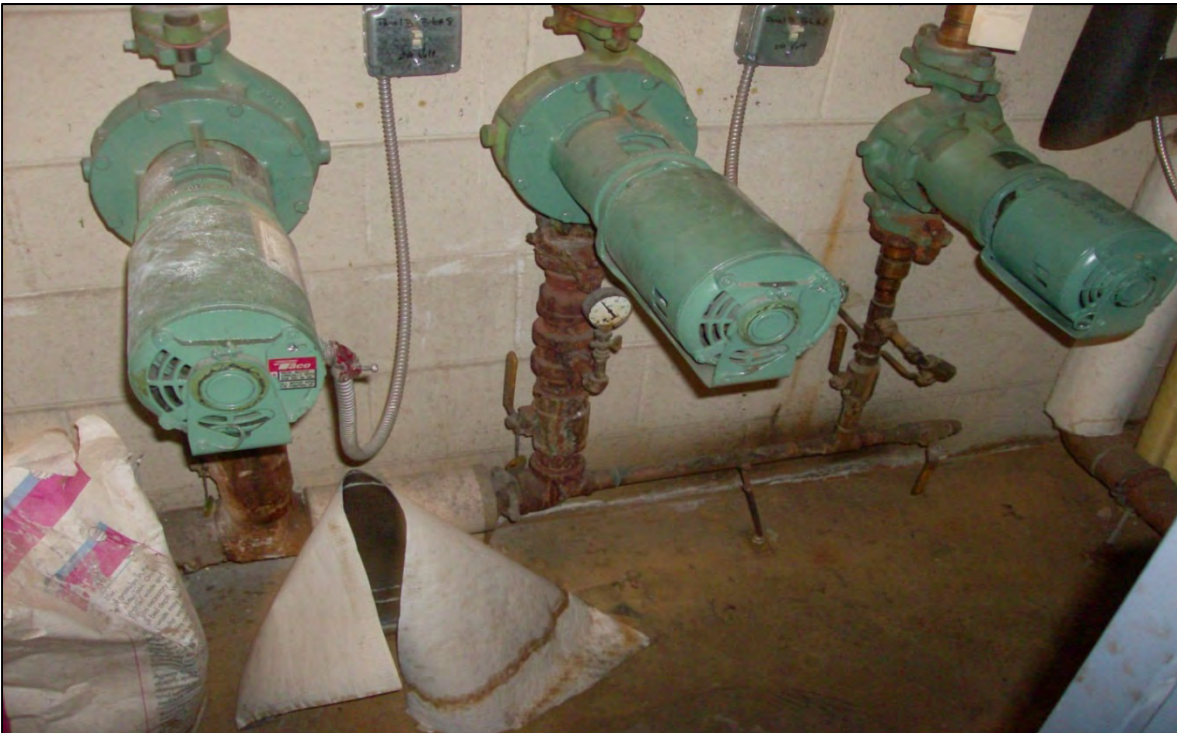
Hot water circulating pumps.

- Upgrade the heating system with a new boiler plant and revise the heating system to include a dual pump system with a variable speed drive for more efficient operation, and a back-up in case of pump failure (\$140,000 to \$160,000).
