FINAL REPORT

EVALUATION AND ASSESSMENT TROY ELEMENTARY SCHOOL 44 SCHOOL STREET TROY, NEW HAMPSHIRE

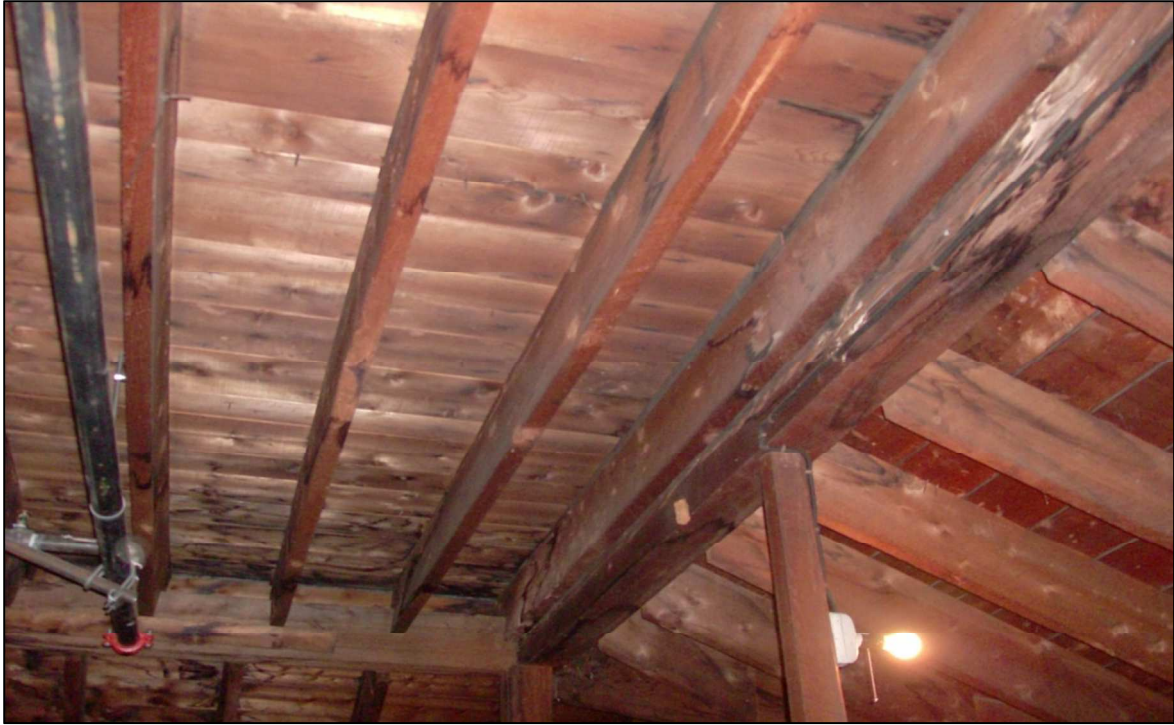
Typical wood framing in the attic. Wood staining may indicate past leakage.

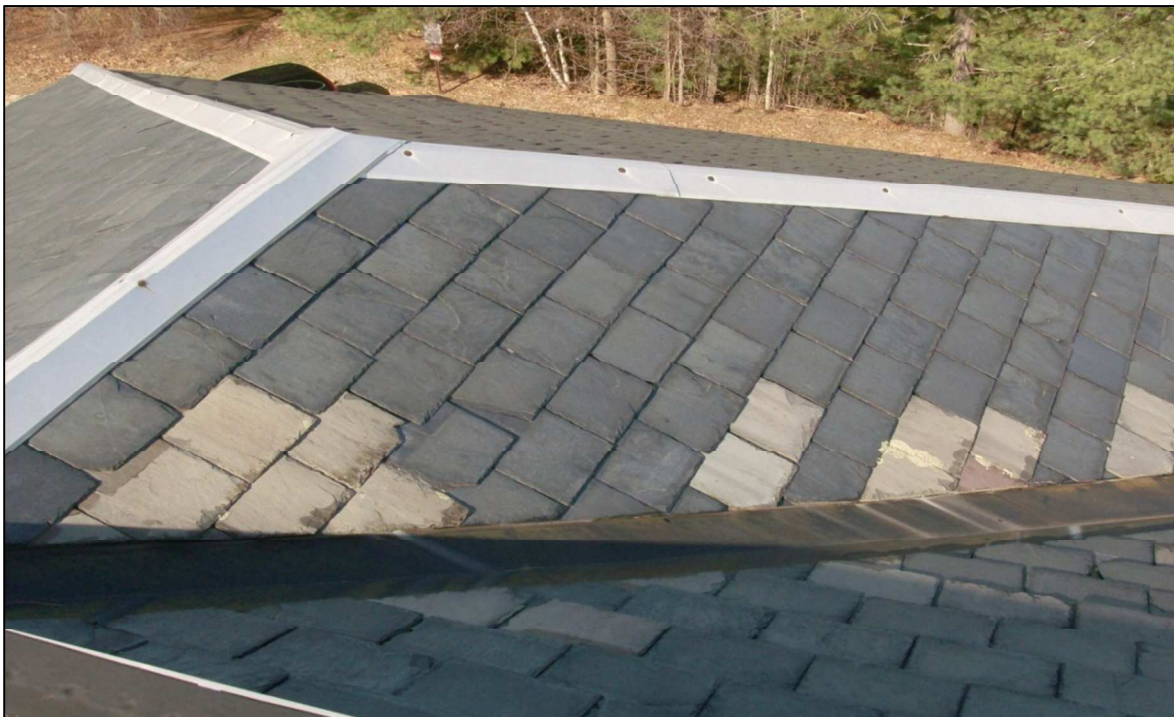
Slat roof over original building. Note replacement slate along the valley.

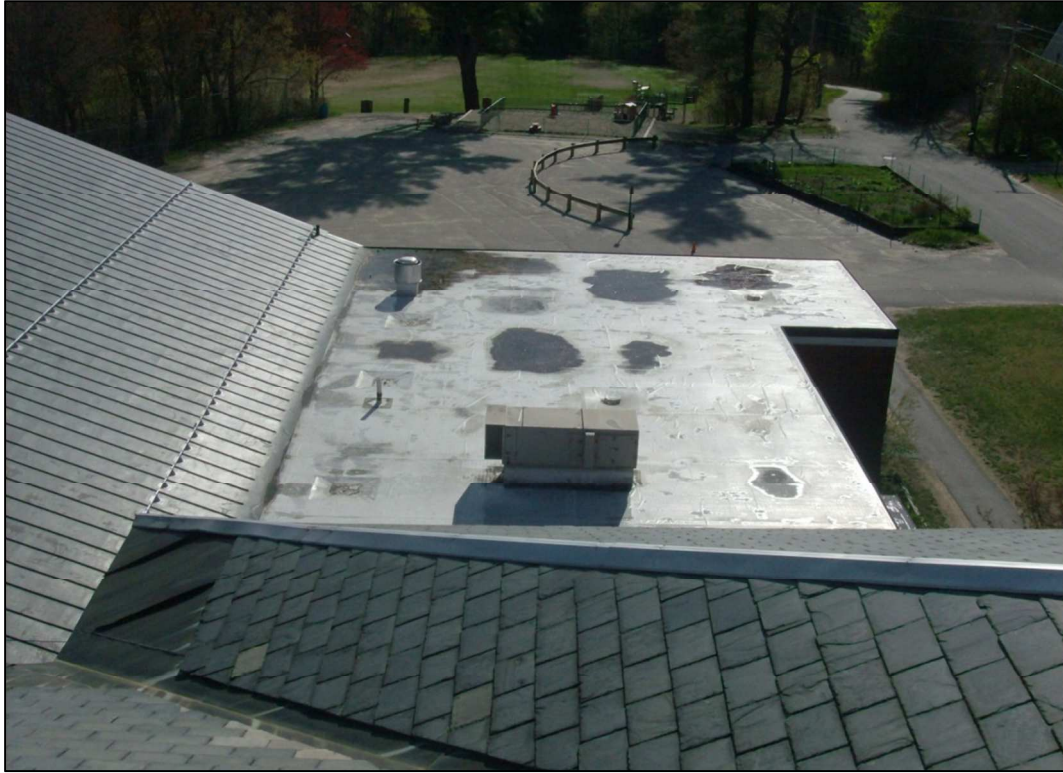
Looking east from original building toward the 1970's addition. Note metal edging along slate roof, water ponding on 1970's TPO roof, and metal roofing with snow guards on gym to the left.
